Southborough Public Library

Southborough, Massachusetts

Conditions Assessment & Restoration Recommendations

December 2018

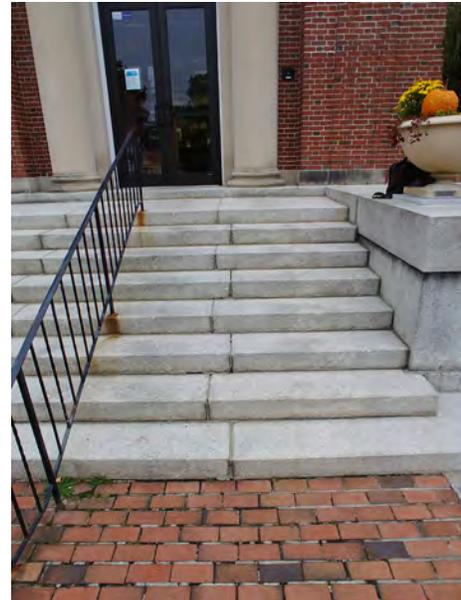
The existing stone and brick masonry stairs require complete reconstruction on new concrete foundations. Many of the stone elements are settling, rotating or migrating due to the freeze-thaw pressures of water infiltration. The rebuilt stone stair slabs and cheek walls should be detailed and built to shed water, or to allow it to drain through appropriate drain holes in the supporting structure.

Granite stair slabs at south entry have shifted and pavers show mortar loss.

- The existing stone masonry cheek walls should be numbered, disassembled and salvaged for reconstruction. The existing front stair stone stair treads should be numbered, disassembled and salvaged for reconstruction. The existing brick paver areas at the front entry stairs should be measured and photographed and then demolished.
- Excavate for new foundations at existing front stairs. Provide new concrete foundations at existing front entry stairs, including cheek walls.
- Provide new brick pavers at front entry stairs; set in sand or stone dust setting bed to match original design and configuration. Reinstall existing center handrail. Provide color-galvanized new handrails on each side of reconstructed stairs.

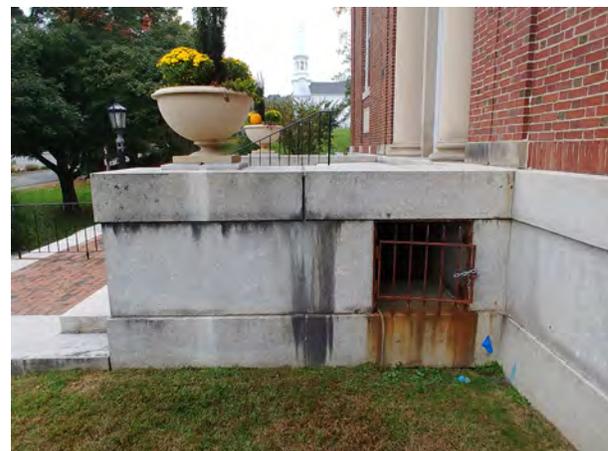
Ferrous staining at granite cheek wall.

- Remove existing steel grilles at both cheek walls, remove iron stains below each opening, and install new concrete masonry infill covered with cementitious coating.
- Clean rust staining at the granite slabs.

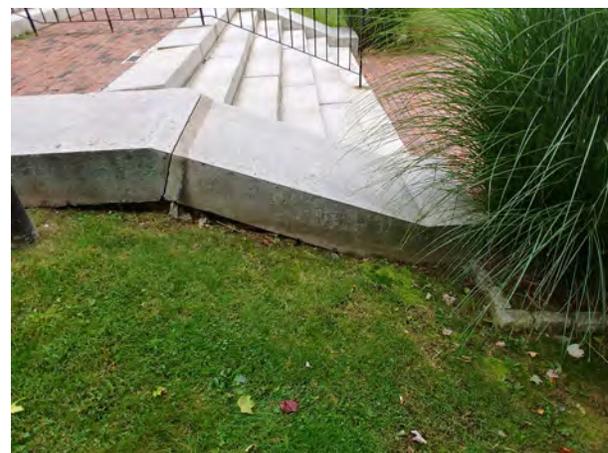
Shifted granite cheek wall at front entry.

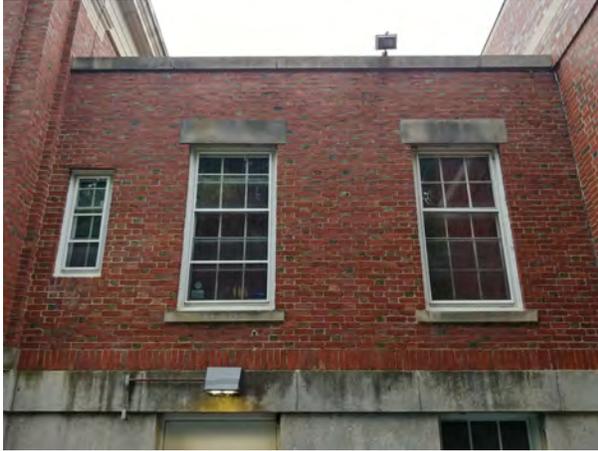
Staining of foundation at east elevation of early addition.

- At the stone water table of the original building, and the concrete foundation of later additions, use stone masonry cleaners to remove mold, soil and other organic materials from all vertical surfaces.

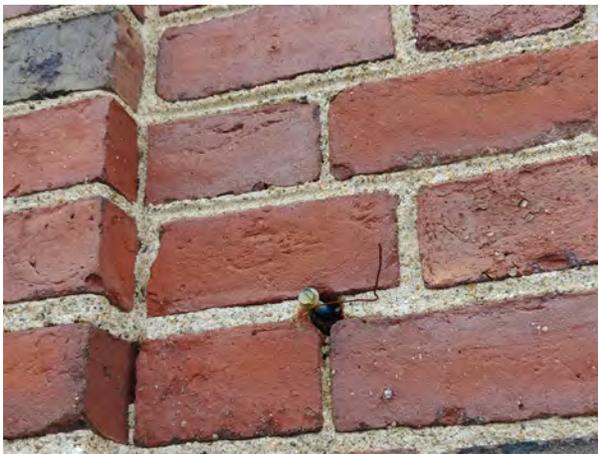
Detail of typical embedded ferrous anchor.

- Removal of embedded steel eyehooks is recommended at numerous locations, to be followed by the repointing of holes in mortar and bricks using properly tinted repair mortars. Similarly, we recommend that embedded iron anchors be cut out and removed at designated basement masonry openings. The resulting holes should be in-filled using properly tinted repair mortars.

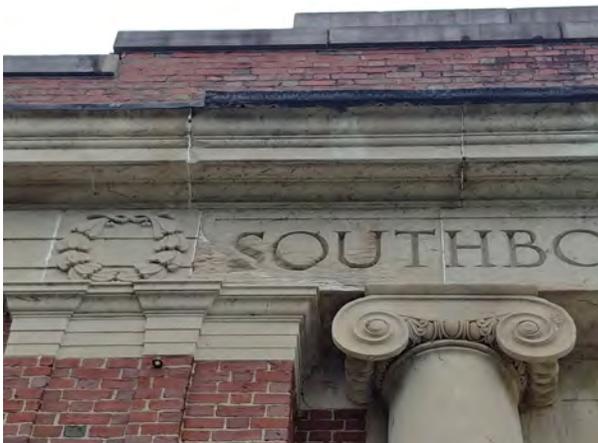
Eroded stone slab at south elevation containing incised lettering.

- At the stone entablature along the south elevation, the stone slab containing the letters “SOUT” is seriously eroded from repeated water penetration, freeze thaw cycles, and the expansion of surface salts. This stone slab should be removed and replaced by a newly carved stone to replicate the existing stone slab.

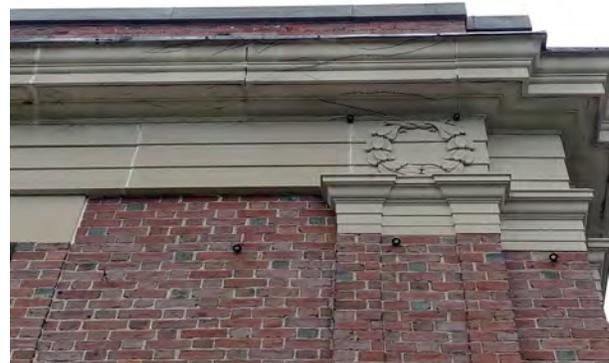
Open joints at sandstone entablature.

- The stone masonry roof cornice and entablature needs to be 100% cut and repointed at all vertical and horizontal joints. At the roof parapets, embedded metal anchors have caused spalling of numerous areas of the stone coping. Loose stone areas need to be pinned in-place. Spalled stone areas should be repaired with new matching stone “Dutchmen,” properly sized for each location.

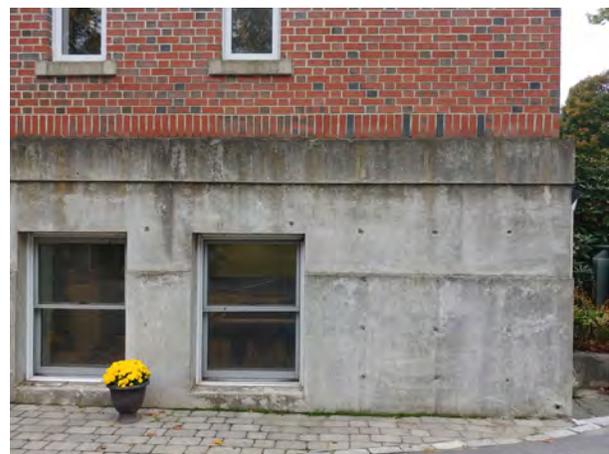
Unfilled snap-tie openings at concrete foundation wall. Staining at water table and wall.

- The snap-tie locations in the concrete foundation wall of the later additions should be wire-brushed to remove rust and then recesses should be infilled with a concrete patching mix.

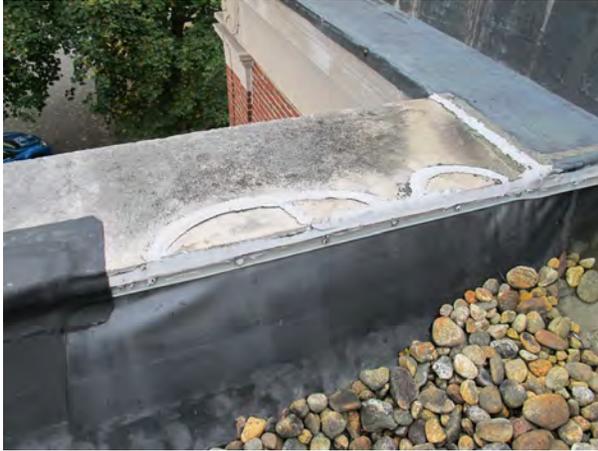
Spalled stone coping at parapet due to improperly installed termination bars.

At the inside face of many existing parapets, the stone coping stones have been severely damaged by the insertion of expansion shields and fasteners into the narrow, vertical inner faces of the coping stones. This has caused the stone to split and crack at the top horizontal surfaces of the stone coping and has resulted in the irregular pattern of patches currently visible.

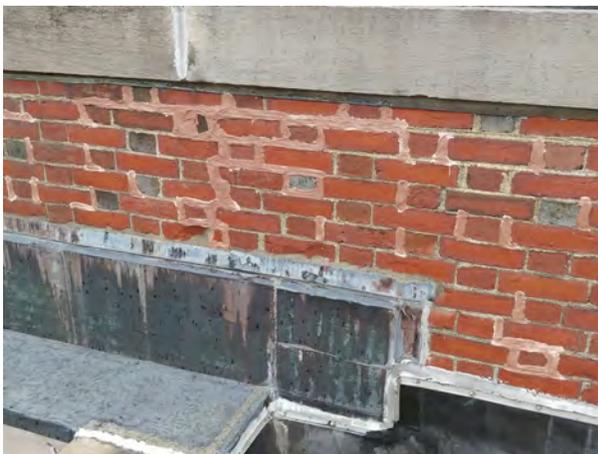
Epoxy compound used for repointing of selected parapet wall areas.

- Removal of disfiguring surface-applied sealants should be performed at selected exterior brick masonry parapet wall areas along the northern portion of the original building. These materials were probably installed to seal defective mortar joints, in lieu of performing more traditional masonry cutting and repointing methods.

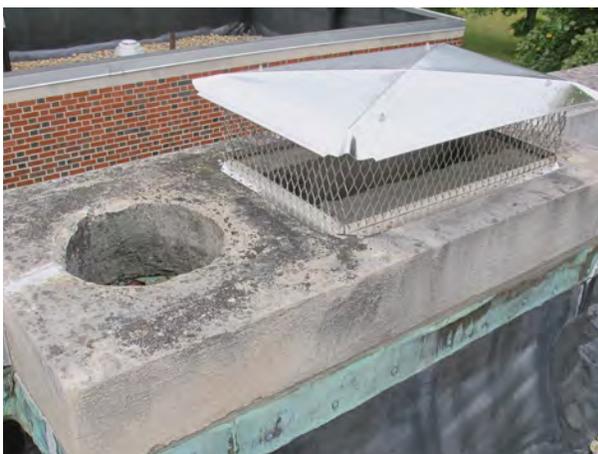
Uncapped chimney flue at parapet.

- Cap one roof-top chimney flue at rear wall of original library parapet.
- Provide new membrane roofs at original building and designated additions.
- Provide new membrane roof at the 1989 rear wing.

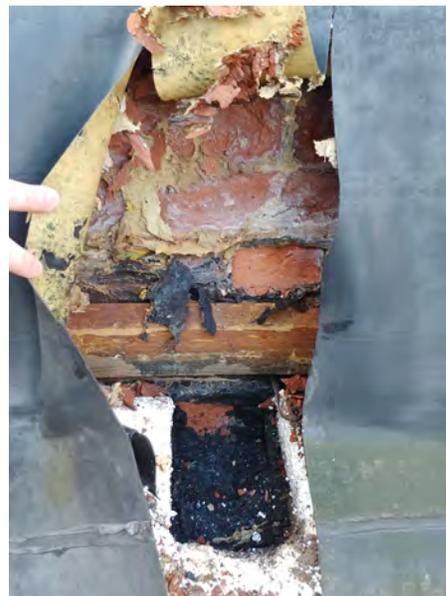
The focus of this assessment was on exterior brick masonry walls, stone trim and the various masonry roof parapets. When roof cuts were performed at the roof of the original building, it was clearly evident that the roof parapets have been damaged by water penetration and repeated cycles of freeze-thaw cycles. The roof parapet at the center of the south elevation is in particularly poor condition, as is the parapet of the first addition above its eastern exterior wall.

Saw cut inside north-facing parapet reveals extreme damage to masonry.

- 100% deep joint preparation and repointing should be undertaken at both faces of the entire roof parapet perimeter of the original building. The east and west parapets of the early addition should be treated in a similar manner.

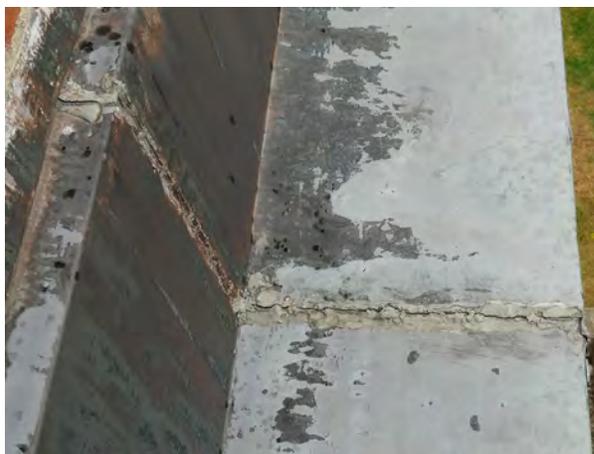
Cracked flashing solder joints.

The existing lead-coated copper flashing at the base of the parapet exterior and the top surface of the main building cornice should be removed and replaced with red copper or Freedom Gray zinc-coated copper. Installation of the new copper should be done with details that provide for proper expansion and movement of the various copper flashing elements.

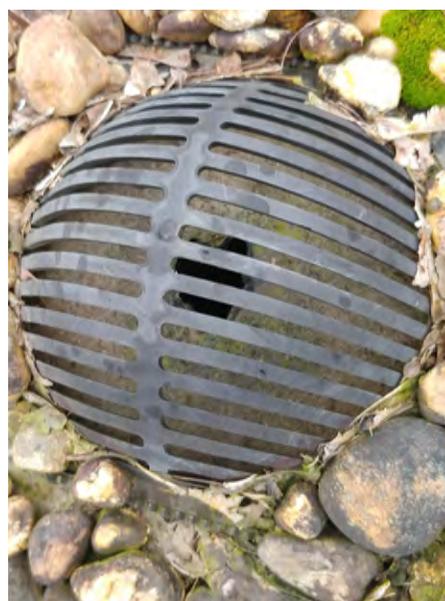
Restricted roof drain pipe opening.

- Remove ferrous fasteners from existing copper through-wall flashing and other locations.
- Enlarge existing roof drain inlets to full diameter of vertical drain pipe below.

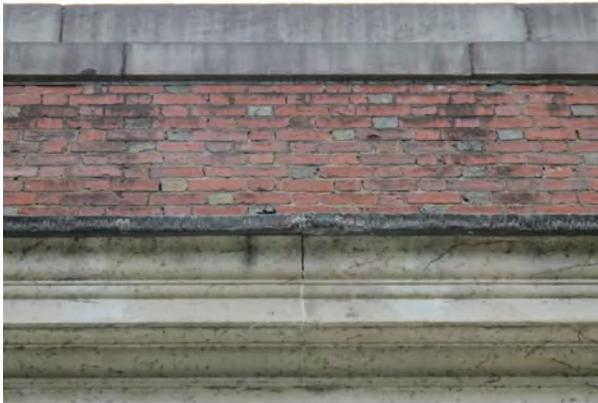
Failed mortar joints at brick parapet above south main entry stair.

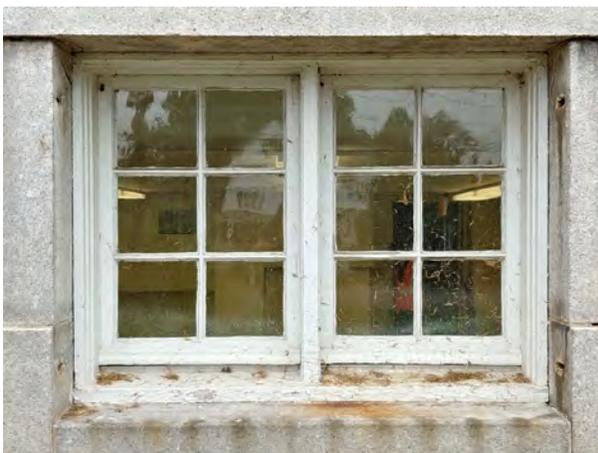
Failed paint coating at basement window, lack of exterior storm windows.

of natural light, particularly in the main reading rooms. The windows' thermal performance was improved by the installation of storm windows, but these windows have reached the end of their service life and need to be replaced. No storm windows exist at the ground level windows of the original building. This is an omission that should be corrected.

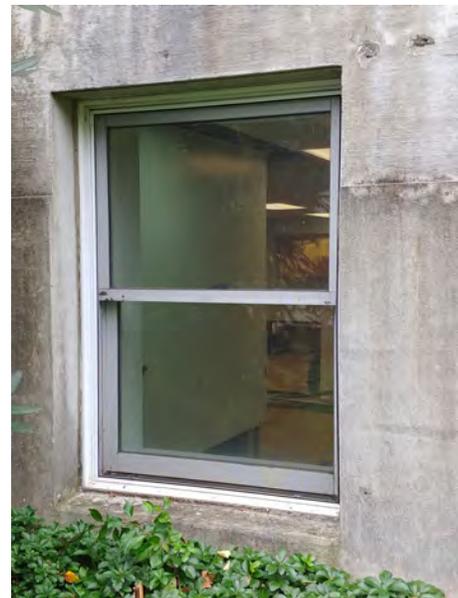
Deteriorated window sash at ground level of 1989 addition.

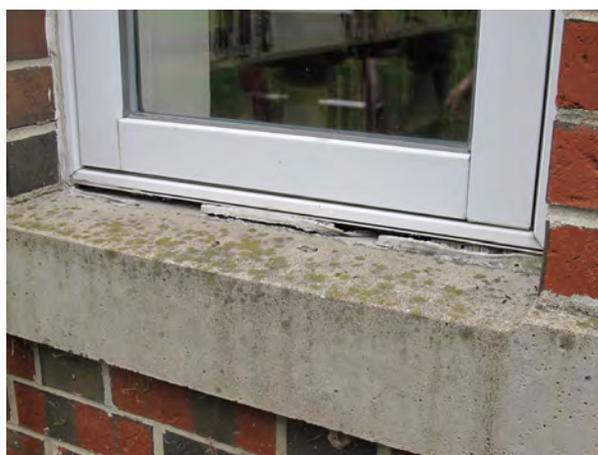
Deteriorated window caulking at 1989 addition.

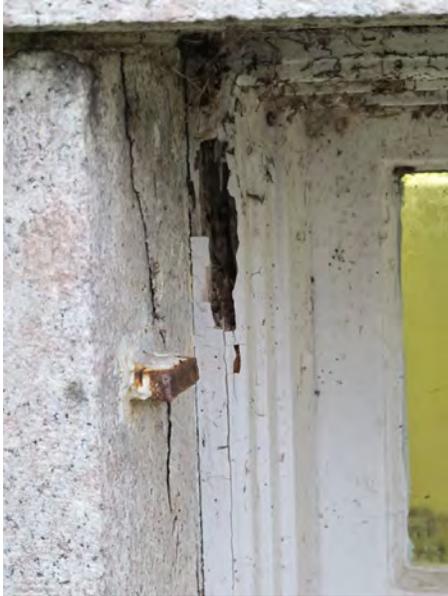
Damaged wood window frame and embedded steel pintle fragment.

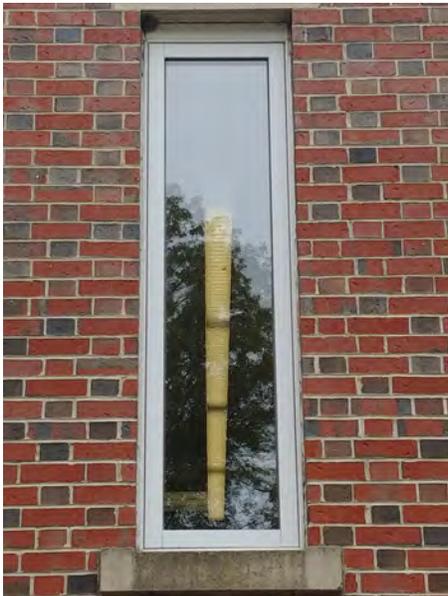
Perimeter sealants at 1989 windows are failing and need replacement.

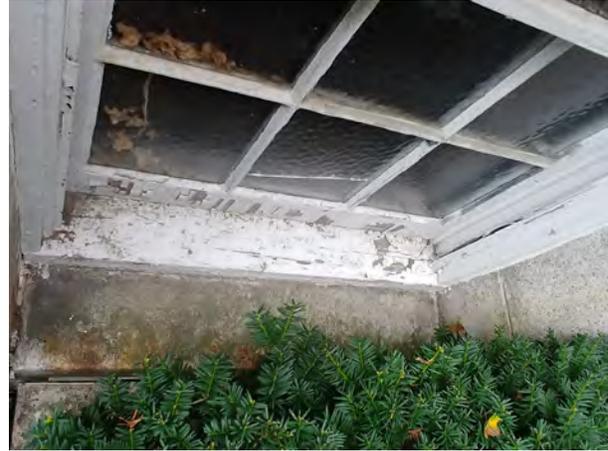
The existing exterior wood window sills are weathered and have open grain, but appear to be mostly solid. The exterior wood frames are in good condition, with some deterioration at the bottoms where the wood can wick moisture from the sill. The same is true of the wood jamb and head mouldings that trim the window adjacent to the building's brick masonry exterior. There is pronounced deterioration and failure of the sealant at the joint between the wood brick moulding and the masonry opening.

Deteriorated window sill at ground level, east elevation.

- At the sills and areas of deteriorated wood, epoxy consolidant and patching materials should be applied to restore the structural integrity of the wood. Given the age of the building, it should be assumed that there will be some lead-containing paint on the painted surfaces, and therefore handling and treatment of the material, and containment and removal of dust and paint chips, will need to follow State regulations for work with lead-containing paint. Regulated precautions for worker and occupant safety must be followed.
- The existing storm windows should then be removed, and replaced with new low-profile exterior storm windows. Low-profile windows are preferred in restorations as they provide good transparency sight lines and are less obvious, allowing the original windows to be the dominant feature of the opening.

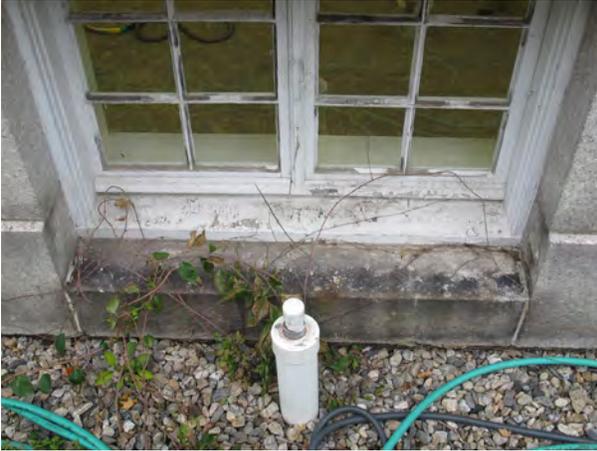
Missing paint on wood elements and glazing.

At the building exterior, all loose paint at the frames, sills, and brick moulding trim should be removed and the wood should be prepared for field-applied primer and finish coats. Remove and replace glazing putty where existing glazing putty is deteriorated, loose or missing. The exterior window elements should be primed and finish coats should be applied as required to achieve full paint coverage.
