CONDITIONS ASSESSMENT REPORT

SOUTHBOROUGH MUSEUM

SOUTHBOROUGH, MA

MARCH 2022 revised JULY 2022

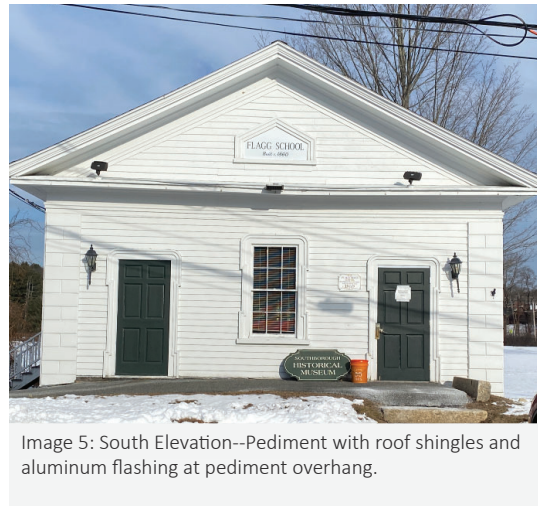
Image 5: South Elevation--Pediment with roof shingles and aluminum flashing at pediment overhang.

We observe the aluminum drip edge at the front overhang is uneven and has been face nailed, which may lead to water reaching the fascia. We recommend replacing the aluminum flashing with copper and creating a drip edge to direct water away from the building. Additionally, replacement of the aging asphalt roof with wood shingles is recommended.

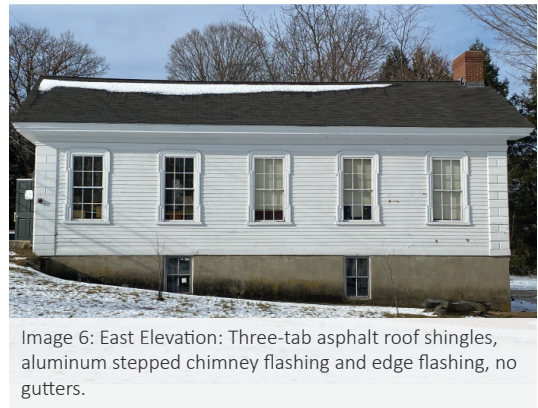
Image 6: East Elevation: Three-tab asphalt roof shingles, aluminum stepped chimney flashing and edge flashing, no gutters.

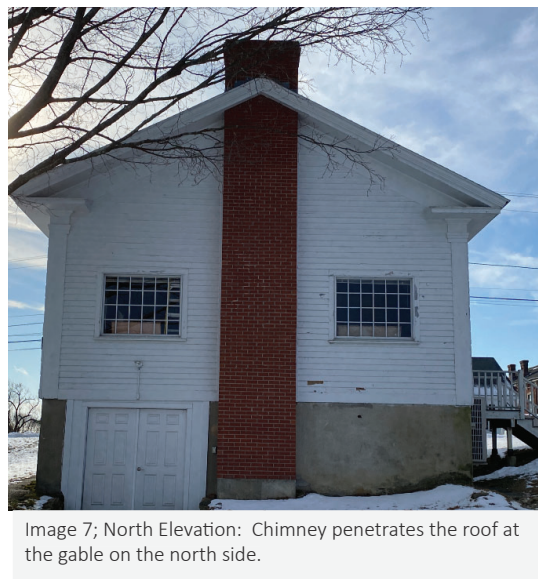
Image 7; North Elevation: Chimney penetrates the roof at the gable on the north side.

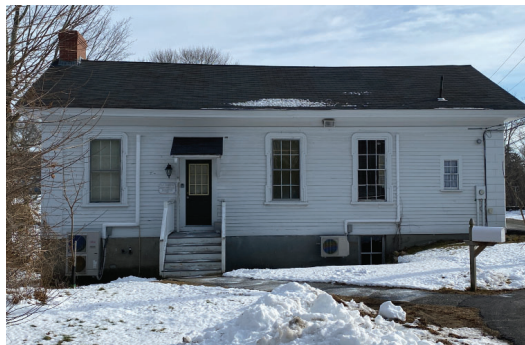
Image 8: West Elevation: The same as east elevation with plumbing vent at right and awning roof over door..

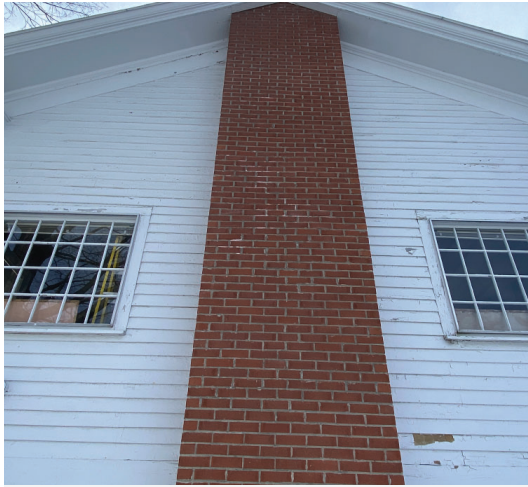
Image 9: Brick chimney on North facade

The chimney on the north facade of the building is red brick, laid in a running bond. The chimney is seven bricks wide and three bricks deep. It is exposed on the north facade of the schoolhouse and penetrates the roof at the overhang of the gable. Three courses of corbelling ornament the top of the chimney--with a mortar wash on top. From the ground, we cannot discern whether a chimney cap covers the opening or not.

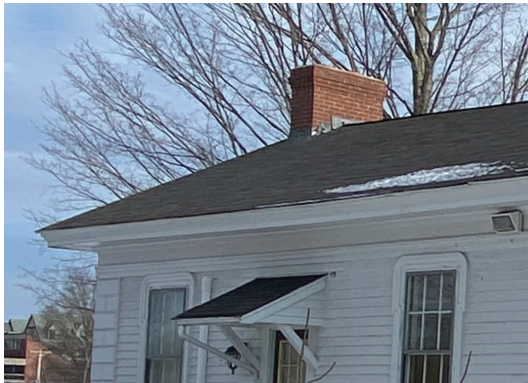
Image 10: View of South side of brick at chimney No more than two lines of text (meaning this is the last line!).

Through a visual inspection from the ground, the bricks and mortar appear to be in good condition throughout.

At this time we do not recommend any interventions to the masonry.

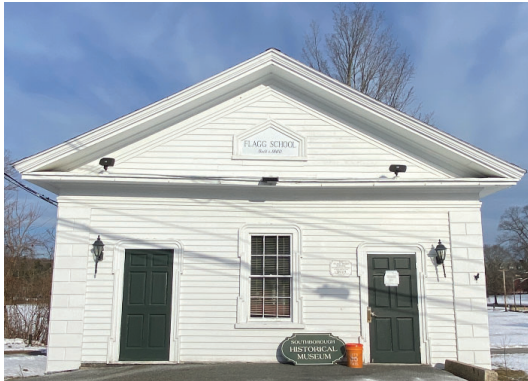
Image 15: Note the pediment featured on the main facade of the schoolhouse.

The main facade of the building is the south facade. It features a clapboard pediment over the entrance with the entablature underneath it (Image 15). In the center is a trapezoidal sign for the Flagg School. The missing, historic flagpole is missing and candidate for restoration/recreation.

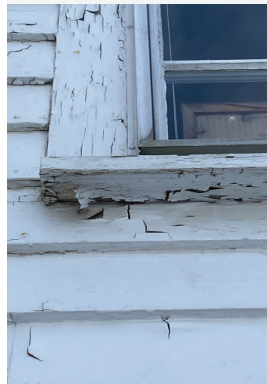
The clapboard and the trim are currently painted white. On all four sides of the building there are places where the paint finish shows alligatoring; places where it has delaminated from the wood clapboards (Image 18); other places where several layers are peeling (Images 19, 20, 21). The condition of the painted surfaces is equally poor on all sides.

Image 19: Siding and Window Trim: Evidence of peeling paint on both..

We recommend scraping, priming and painting all wood surfaces. At the joints between the trim and clapboard, we recommend sealing these gaps (Image 22) with a paintable caulk. All nailheads that have surfaced should be hammered flush with the wood surfaces along with loose building elements (Image 20). Recreating/restoring the historic flagpole would be a worthy addition to scope.

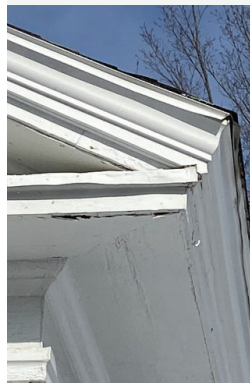
Image 21: Evidence of peeling paint at soffit.

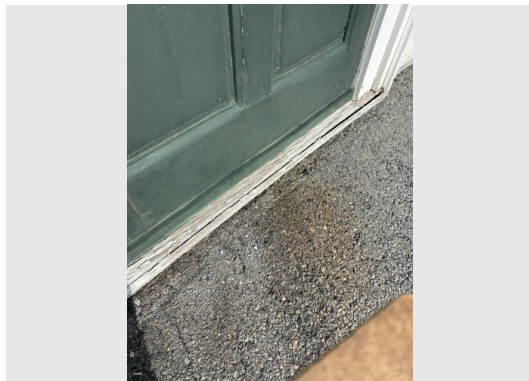
Image 23: Sill of Front Door--The sills at both front doors are deteriorating and should be replaced.

With the exception of peeling paint, the two doors are in good condition. The lead flashing over each door is also in good condition (Image 24). However, the threshold of each door is worn and deteriorated (Image 23). The six-over-six lite window has also suffered from deterioration. The putty at the muntins needs to be stripped, reglazed and repainted along with the sashes and trim (Image 25).

Replace thresholds on south facade.

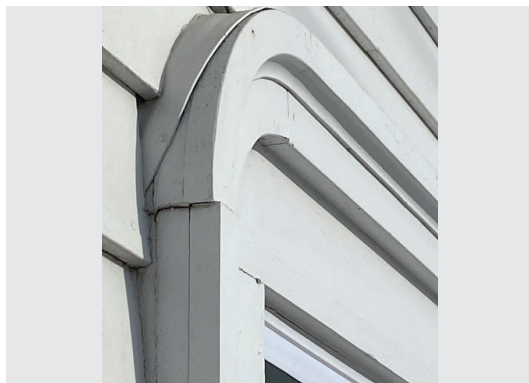
Image 24: Lead flashing over front door trim.

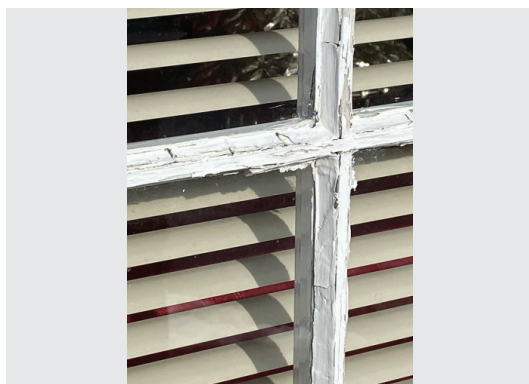
Image 25: Muntin on front window: Example of putty In need of stripping, reglazing and repainting, a common condition.

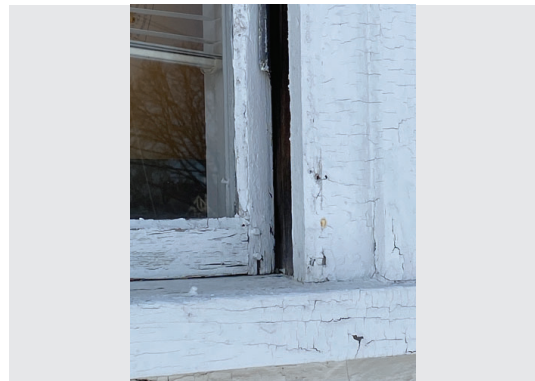
On the east elevation, five six-over-six double hung windows let the light inside. The condition of all the windows is similar. Reglazing is needed at all the muntins. The sash cords and balances are broken on several windows. The stop and casings are broken at the bottom right on one window (Image 26). We also note that no storm windows were attached to the outside of the building on the east elevation, although evidence that they once existed was apparent from screw holes in the casings.

Image 26: Example of broken stop at the bottom sash at one of the six-over-six double hung windows. .

- Replacing stops and broken window casings at original windows where needed on main level
- Replacing sash cords and balances where needed
- Replacing the parting beads
- Replacing sash locks across all windows to match and lock the sashes and to reduce infiltration of outside air

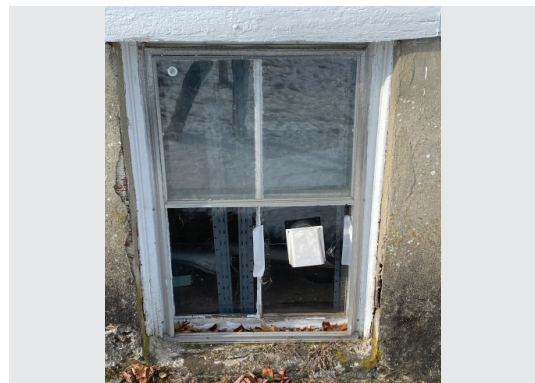
The two basement windows, not original to the building, are in fair condition. Some storm windows are attached to these windows. Their sills have deteriorated (Image 27).

Image 27: East Elevation Basement Window--Sill is deteriorated. Storm window missing.

Replace sills at basement windows

Regrade the ground at the basement windows to insure that water runs away from the building, preventing window sills from becoming saturated.

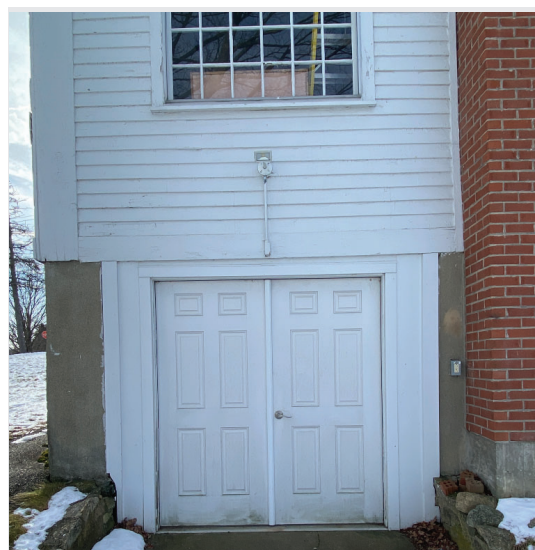
On the north elevation, the service door to the basement level is in good condition. The windows on the main level are generally in good condition, though paint is peeling on the muntins, sashes and trim. (Image 28).

Image 28: Basement Service doors.

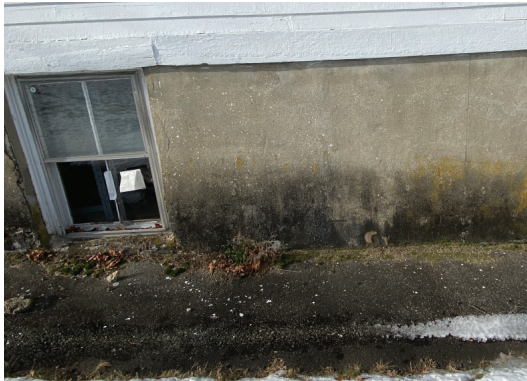
Image 29: Foundation Wall--Stains from splashing at the drip line are evident on foundation wall. Delamination at window.

The foundation is visible on three sides of the building. The cementitious parging applied to the brick foundation is delaminating in various places on all three sides. Additionally the bottom foot of the foundation is discolored from the splashing caused by dripping of rainwater from the edge of the roof on to the asphalt surrounding the foundation wall.

We recommend patching the parging on the brick foundation wall. Further, we recommend removing the asphalt paving and laying a crushed stone apron extending from the foundation away from the building to beyond the drip line in order to eliminate splashing dirt onto the foundation wall.

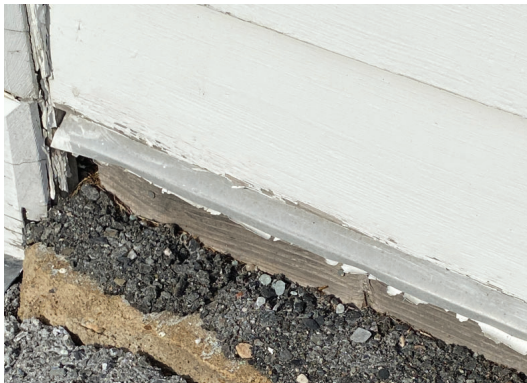
Image 30: Asphalt walkway at front facade is touching the wood clapboards.

On the south facade, where the asphalt walkways meets the clapboard, we recommend addressing the problem of the asphalt touching the bare wood clapboard in a redesign of this walkway discussed in the recommendations of the next section.

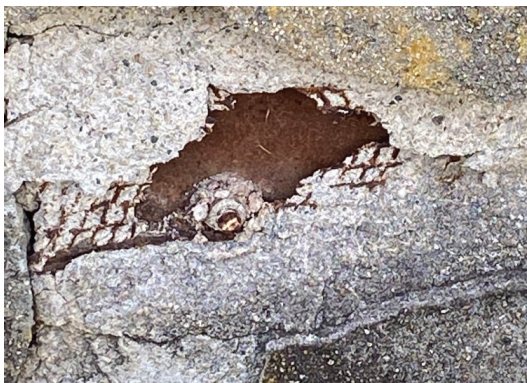
Image 31: Delamination of parging over brick foundation: Deteriorating wire mesh is visible.

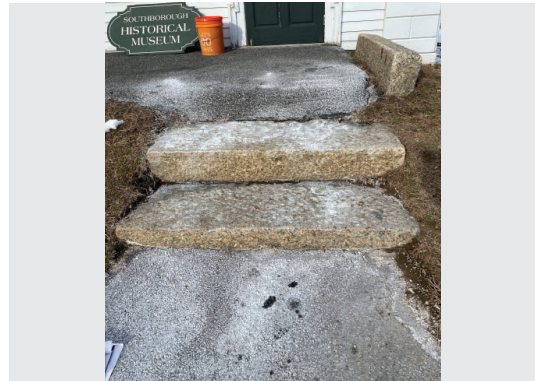
The asphalt walkway for the accessible path is in good condition at the moment, though it should be monitored for changes in its surface. The granite steps and asphalt step leading to the main entrance are of uneven rise. The granite block to the right of the asphalt is beginning to tip. Last, there are no handrails (Image 32).

Image 32: Granite steps to main entrance: Step are of unequal rise, and pose a tripping risk. Granite block at door is tipping..

We recommend a redesign of the accessible entrance and the granite steps. This redesign would include granite slabs that rise evenly, a handrail at the steps and railing at the entrance and a walkway that does not touch the clapboard on the front facade.
