Roof Asset Management Program

Margaret A Neary Elementary School - Roof Insection

June 26, 2025

Roof Section: EPDM Roof Section

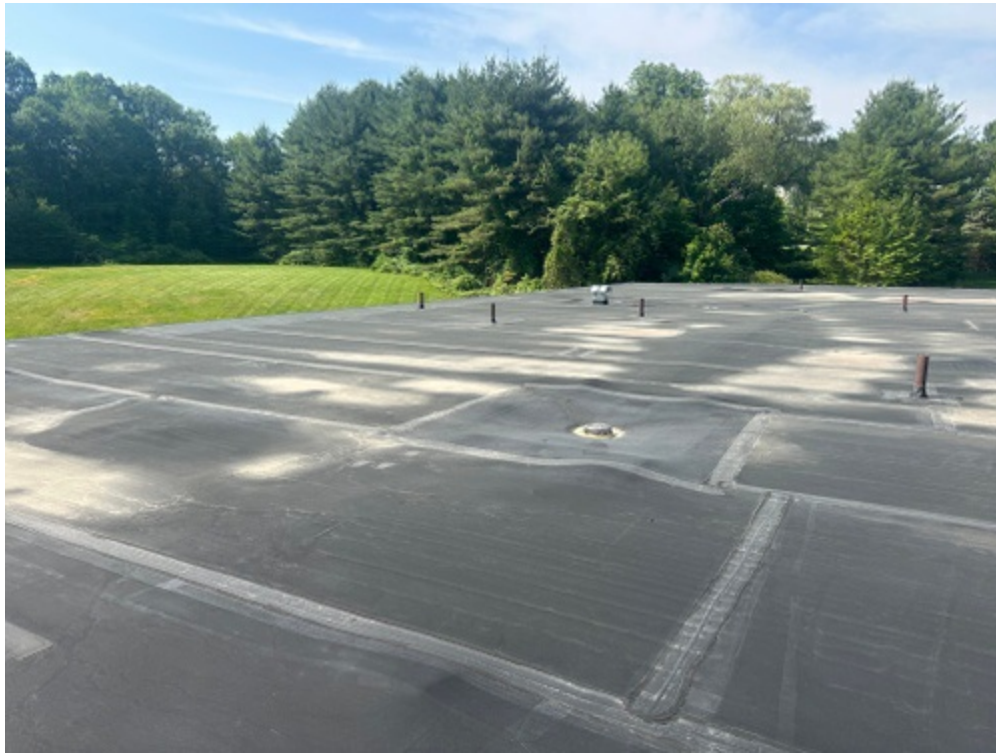
Photo 1

The insulation is completely failed and lifted across the entire roof system. The insulation has become detached from the structure and is essentially floating between the roof deck and the roof membrane. Catastrophic failure is imminent. Walking on the roof is dangerous as well due to voids where insulation should be causing a tripping hazard. This condition is present across the entire roof system.

This roof has completely failed and there are little options available, other than replacement, that exist for this roof. Close attention should be paid to the areas of lifted insulation because once this happens, it only takes one strong wind storm to cause a catastrophic failure. Water is coming into the roof system from all over and although there are not many leaks present in the building, the water is going somewhere. Indoor air quality risks are high. This building has a tectum roof deck which is highly susceptible to water damage, if deck replacement is needed, your already high budget for this roof will increase exponentially. This roof needs to be replaced ASAP, it is past the point of no return and there are no real options otherwise. Repairs are a waste of money at this point, other than for stop gap or emergency purposes.

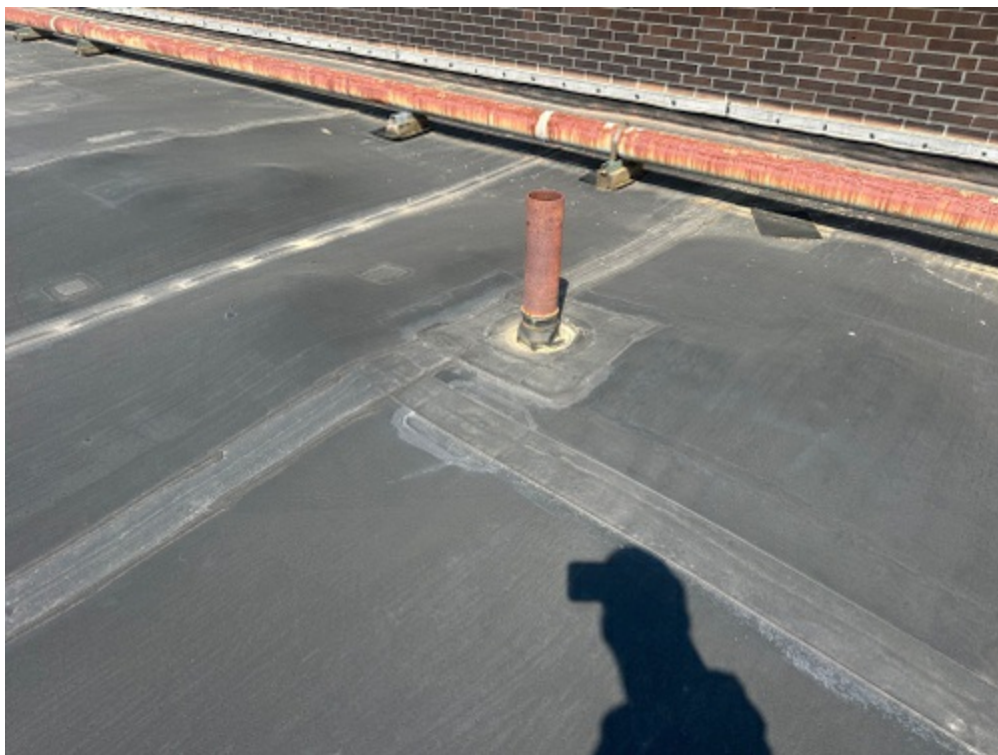
Photo 2

More failed insulation.

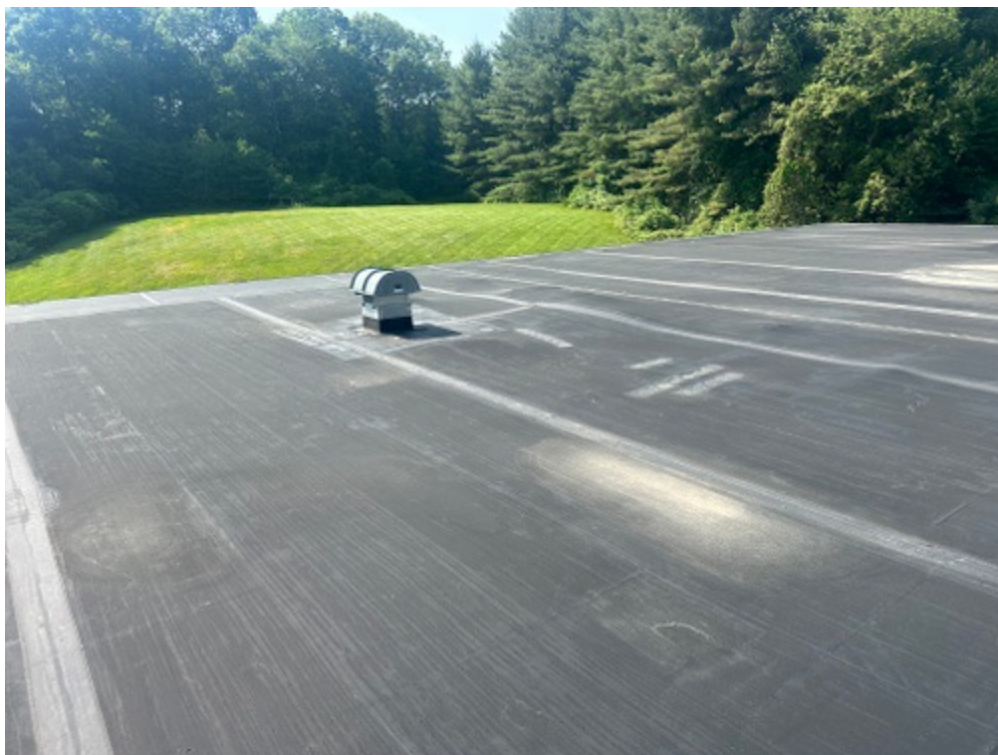
Photo 3

Failed insulation.

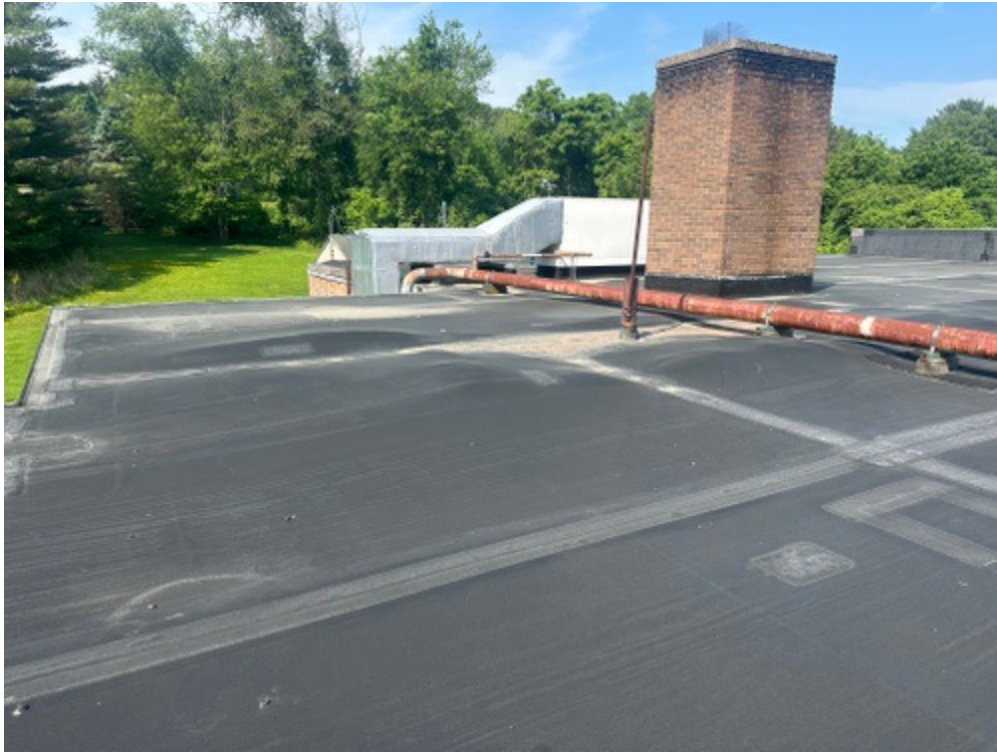
Photo 4

Failed insulation.

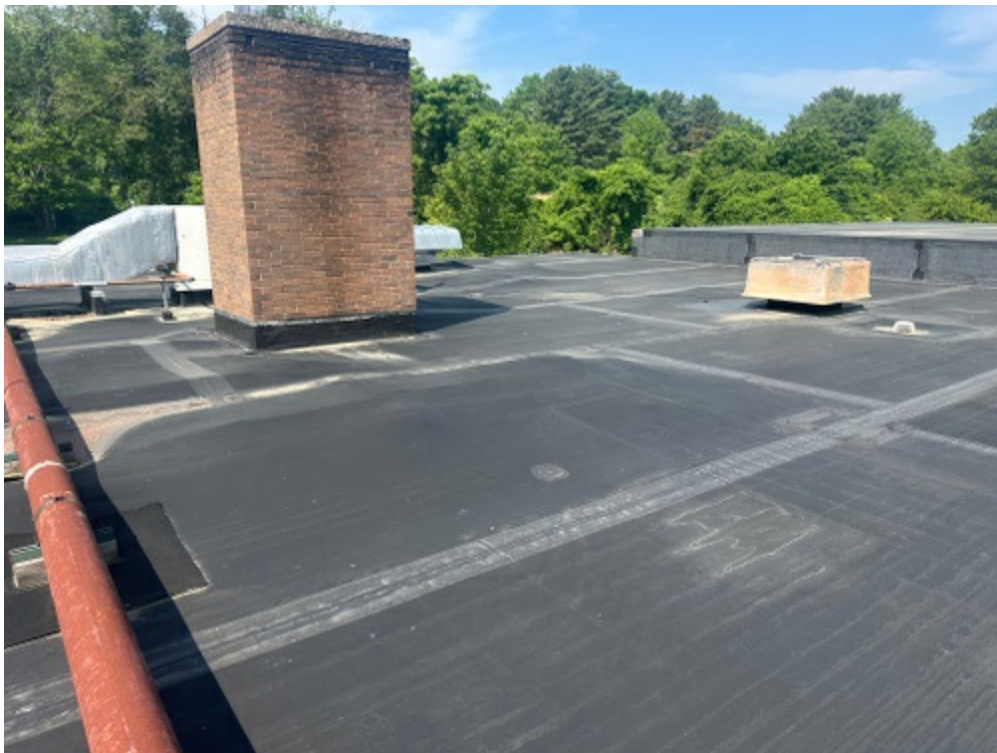
Photo 5

Failed insulation.

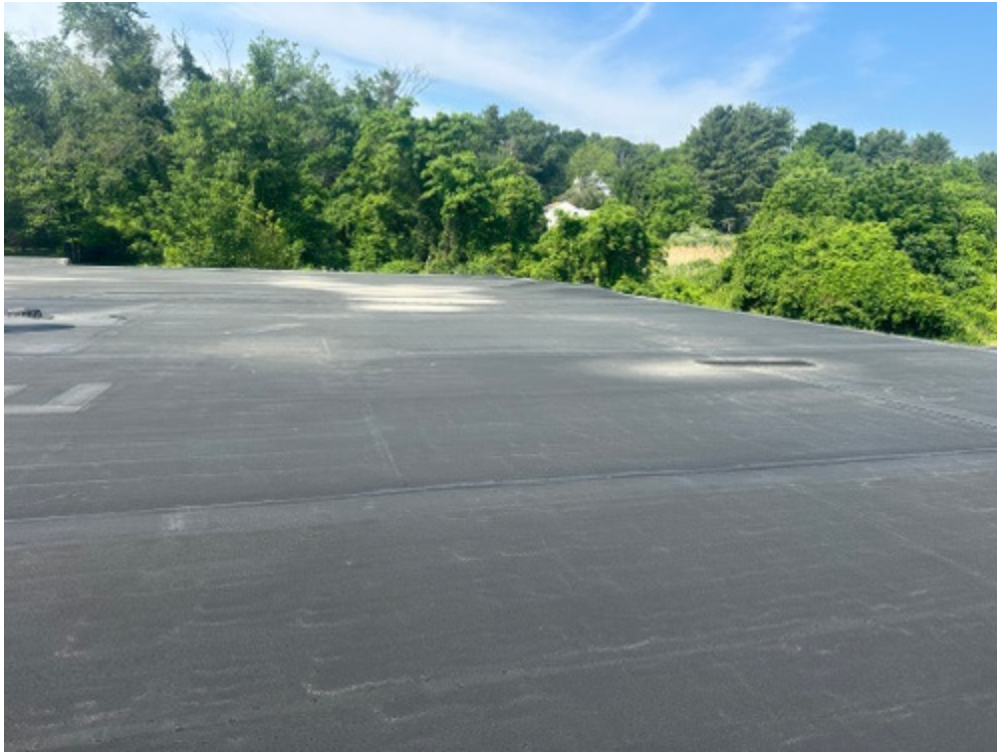
Photo 6

Failed insulation.

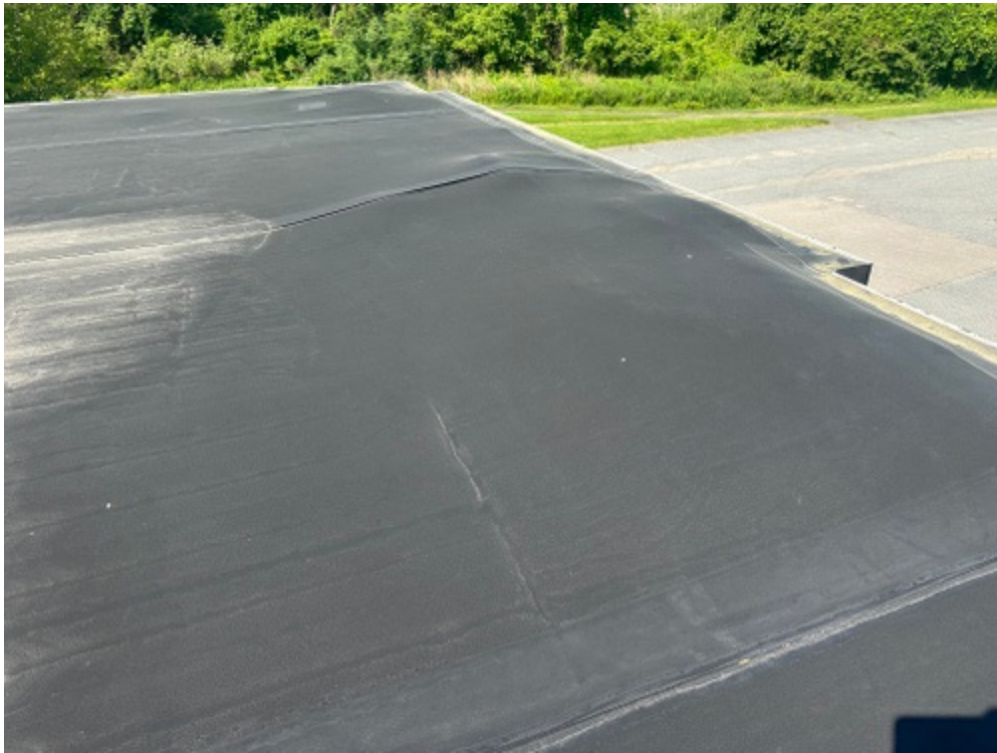
Photo 7

Failed insulation.

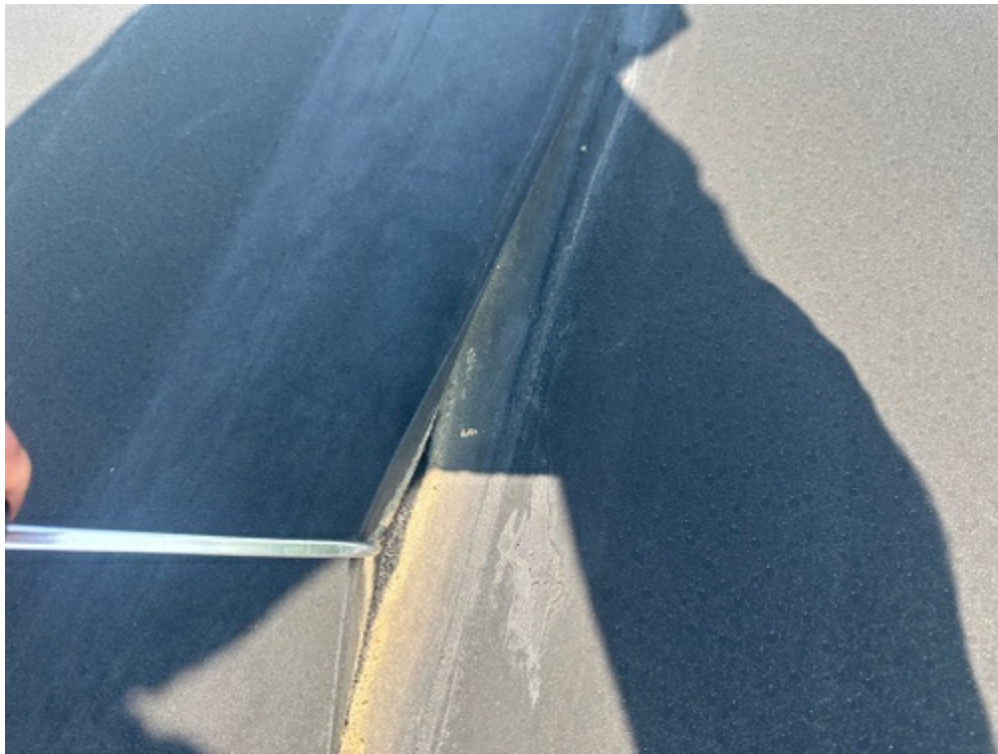
Photo 8

Not only has the insulation failed, most of the seams are completely open. Although the amount of leaks in the building don't match the condition of the roof, water is entering the roof system and more than likely is going somewhere. Indoor air quality should be a major concern.

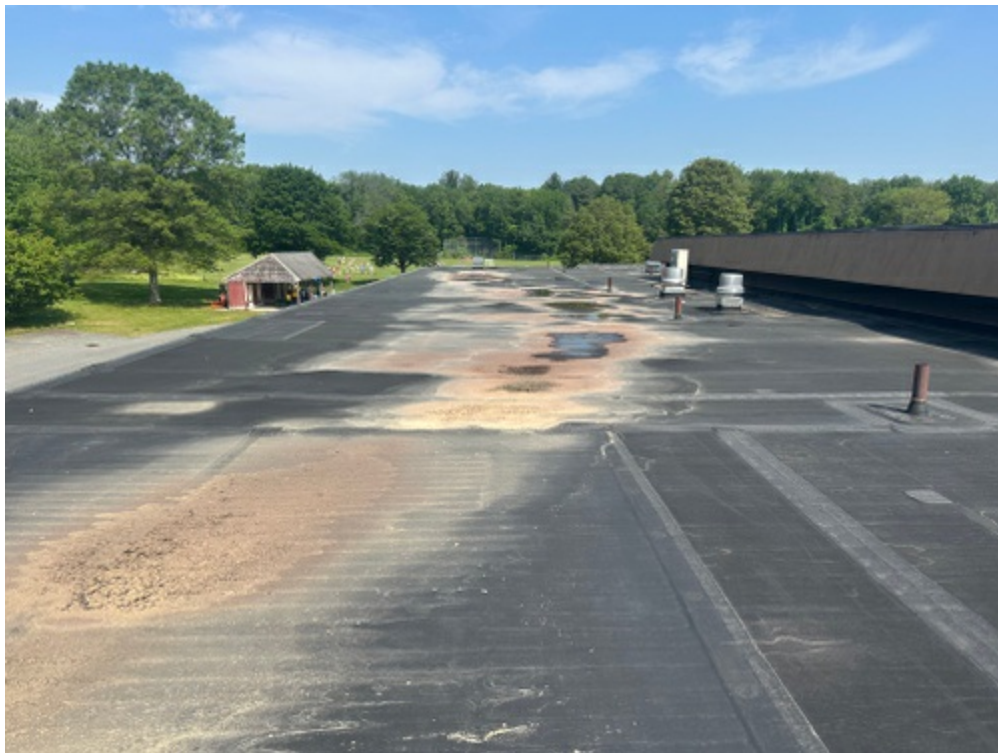
Photo 9

This section is completely failed and never drains.

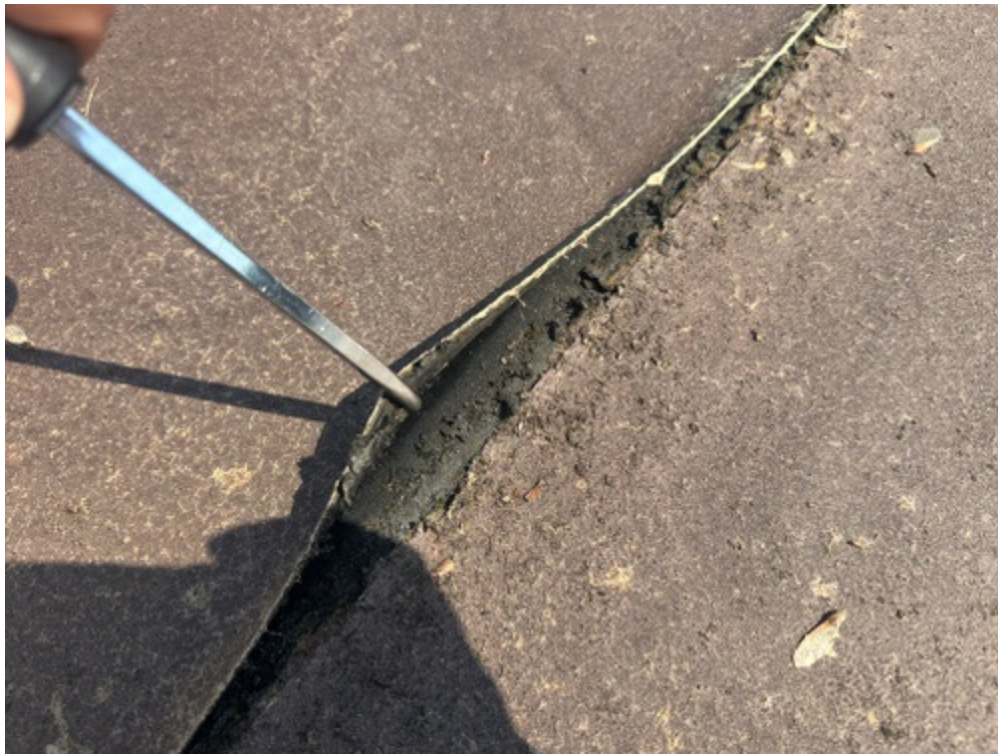
Photo 10

The seams are open in the area.

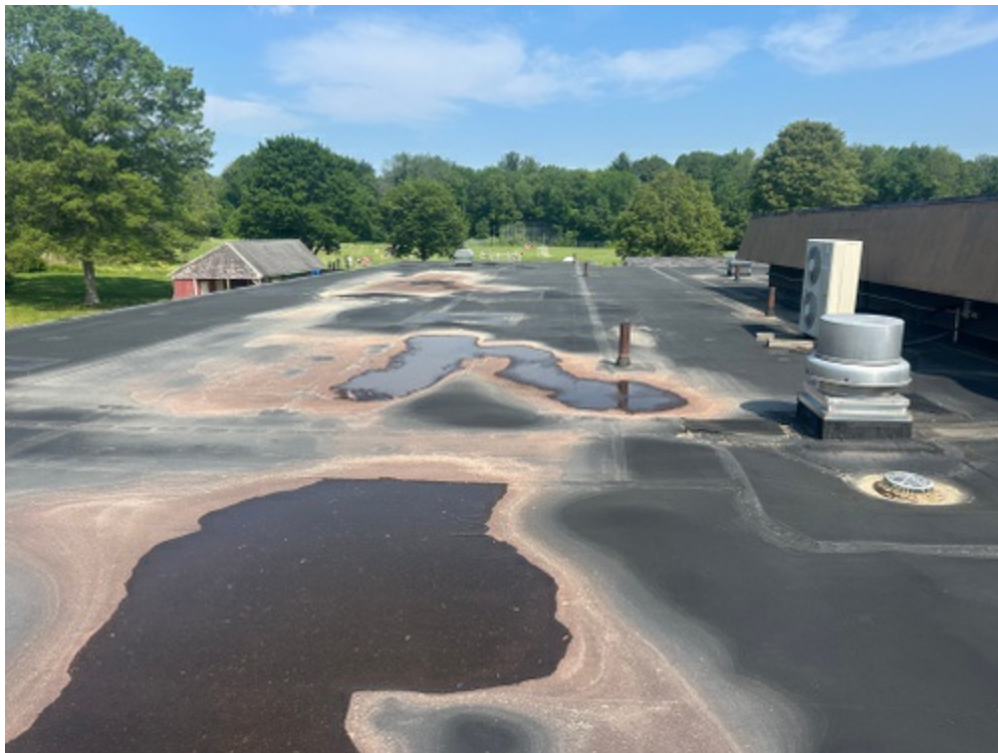
Photo 11

Water was still present on the roof and it had not rained for more than a week.

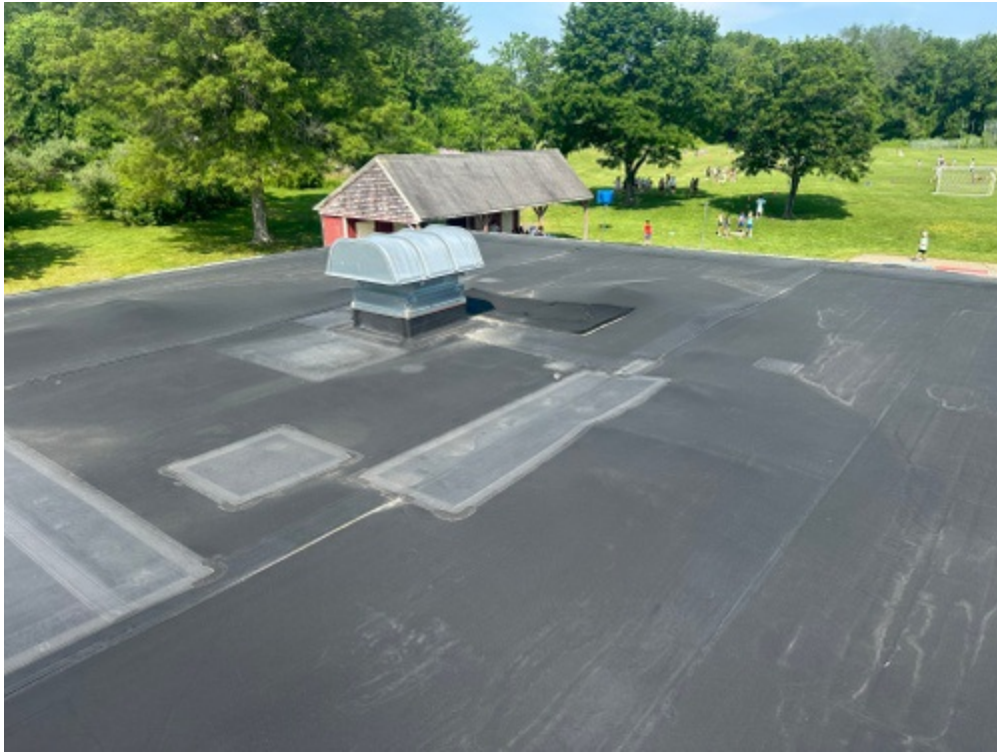
Photo 12

Failed insulation.

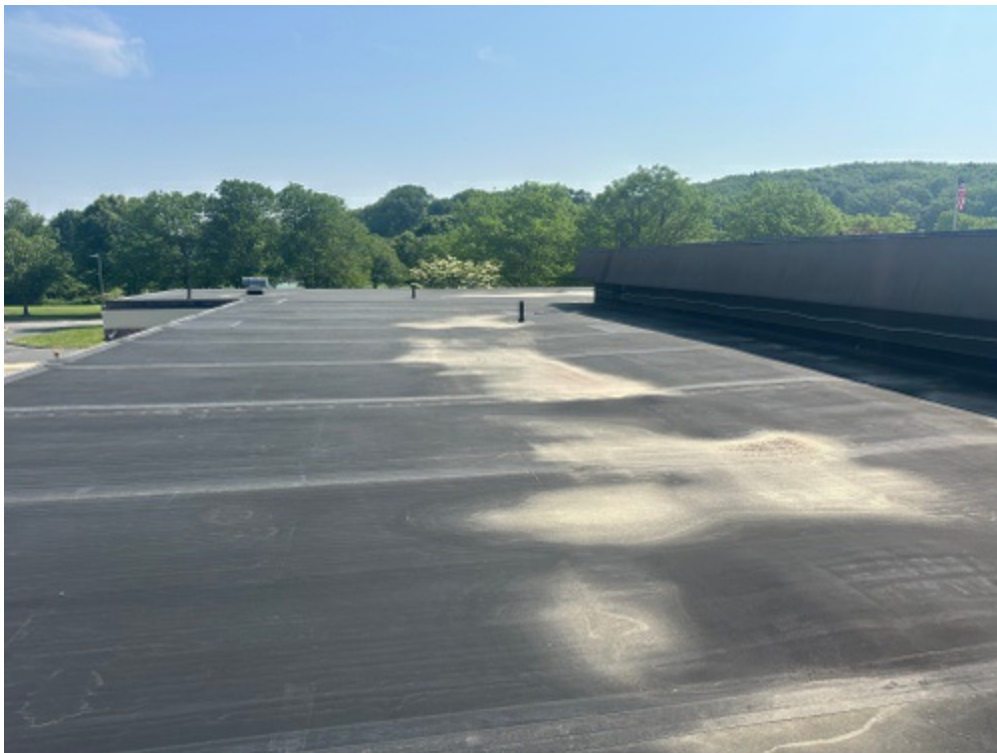
Photo 13

Failed insulation.

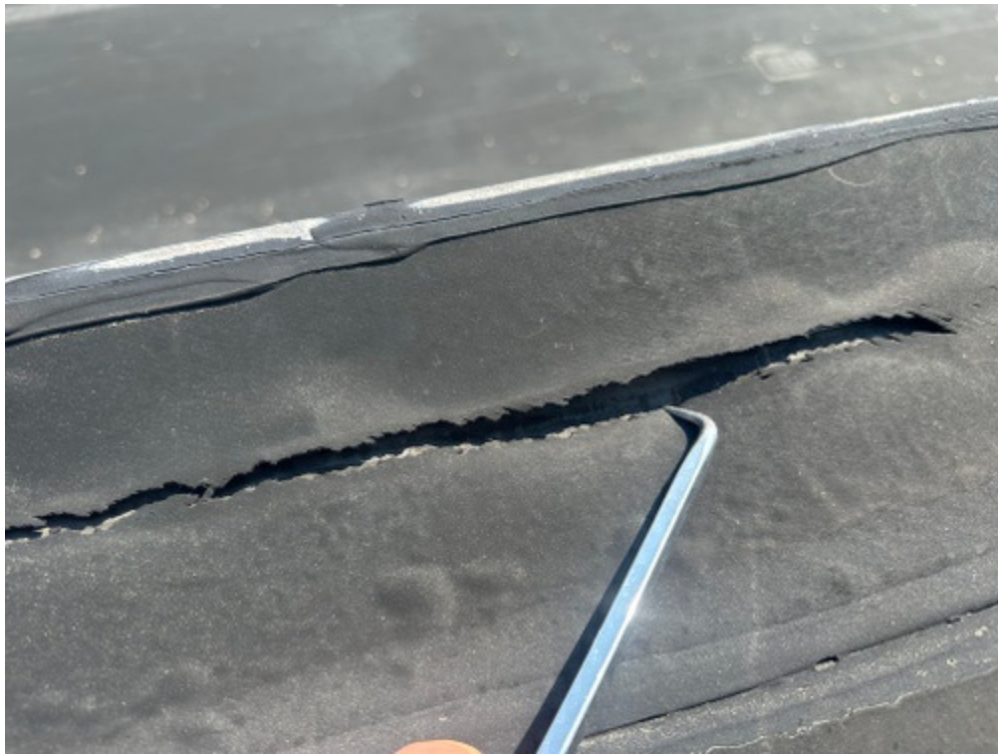
Photo 14

The EPDM membrane is so old that it has no elasticity left and the entire perimeter is torn since it can't expand any more.

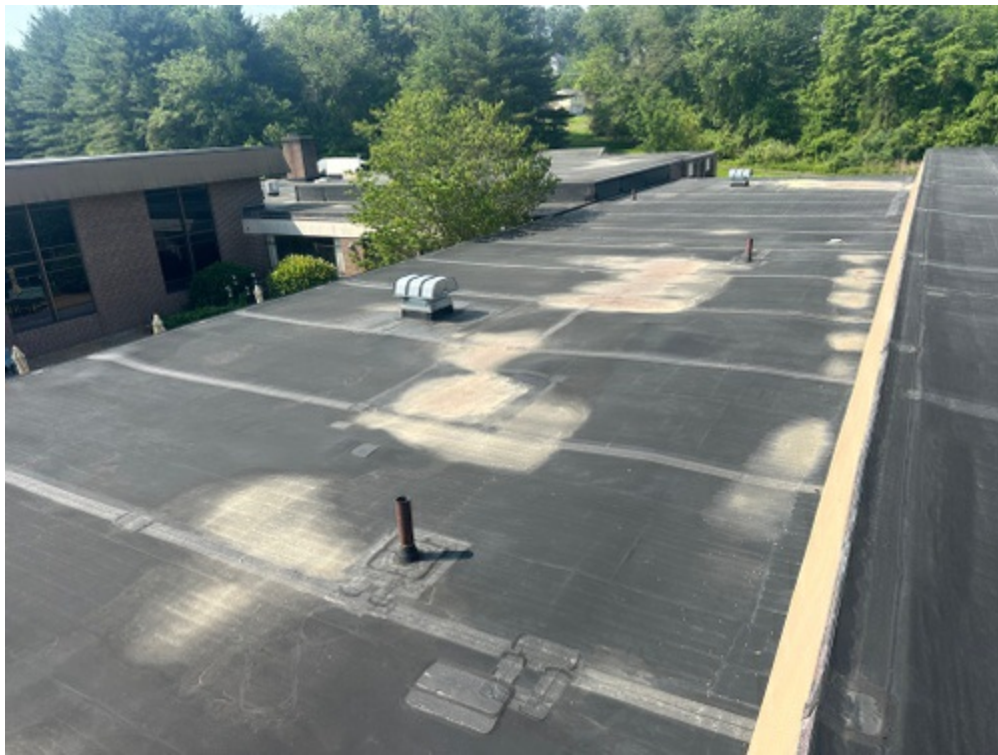
Photo 15

More ponding and failed insulation.

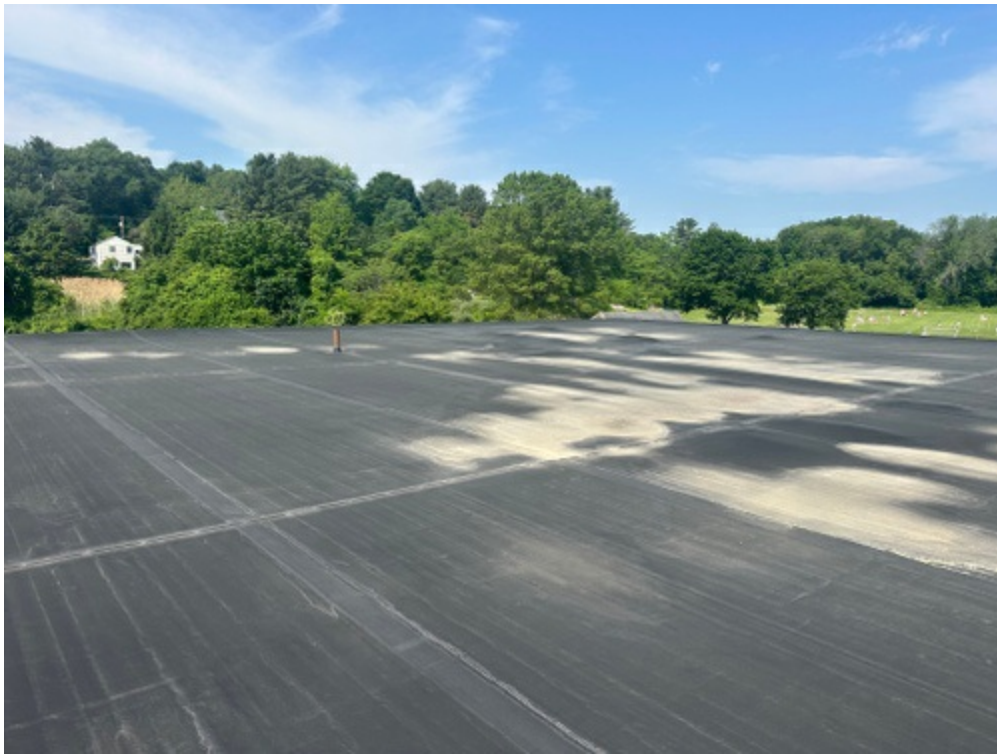
Photo 16

More ponding and failed insulation.

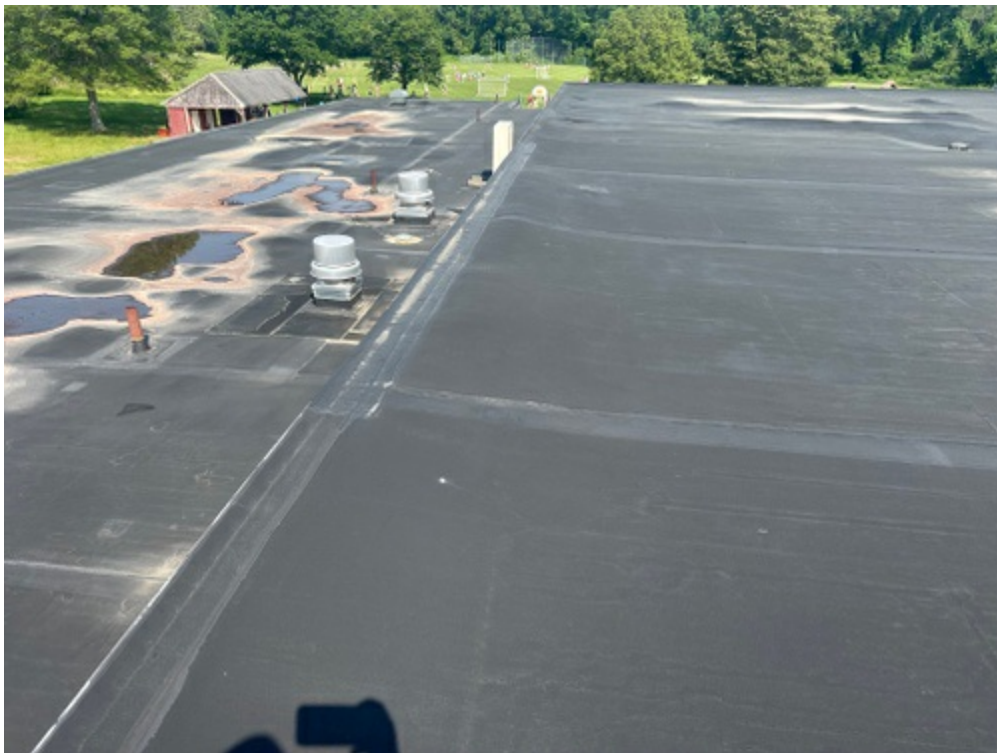
Photo 17

Failed insulation.

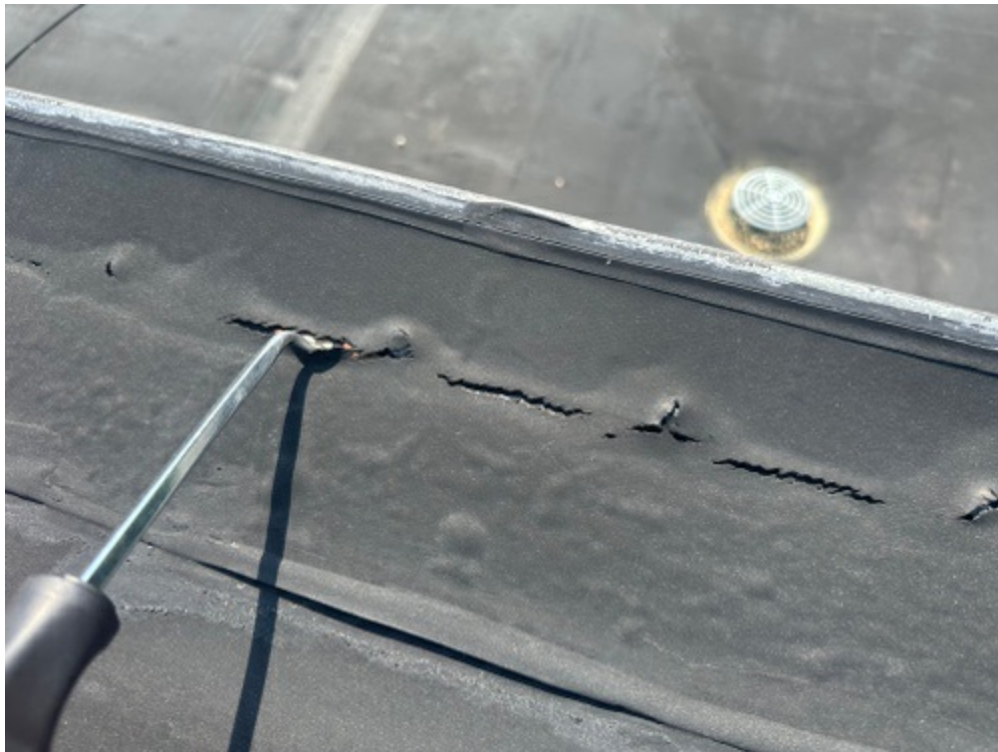
Photo 18

Torn perimeter.

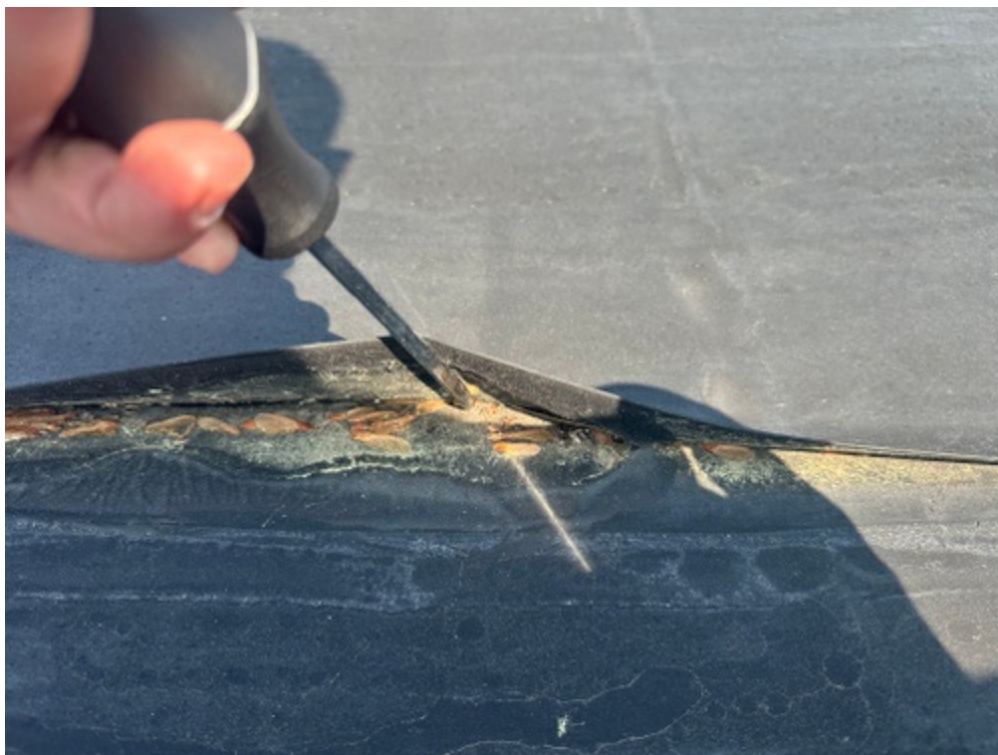
Photo 19

Failed seam.

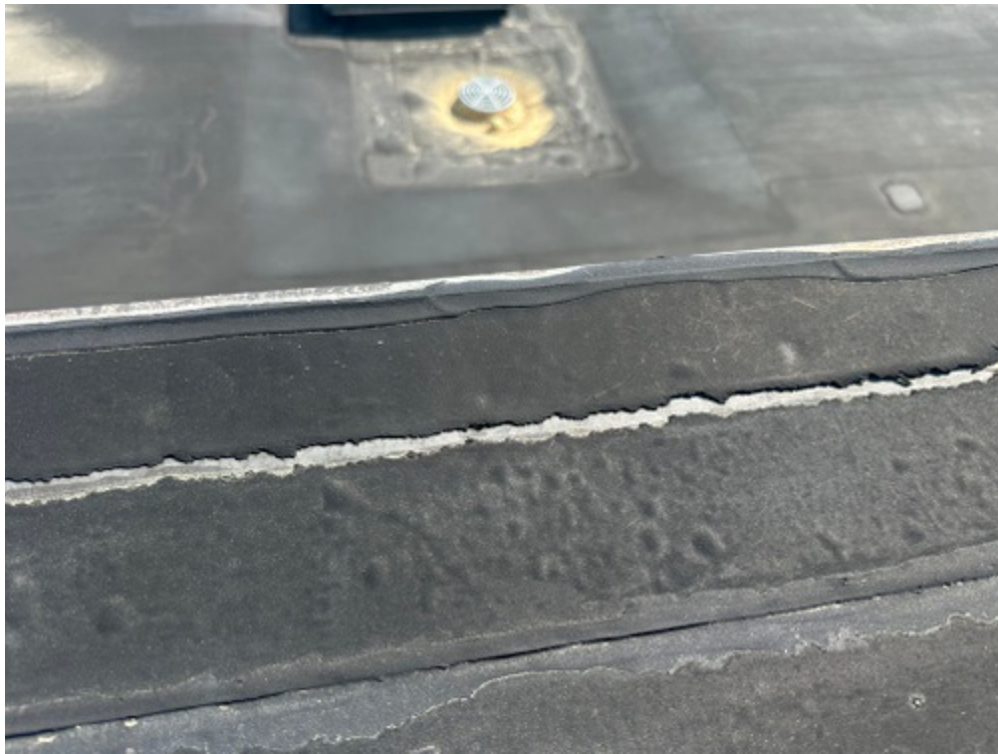
Photo 20

Torn perimeter.

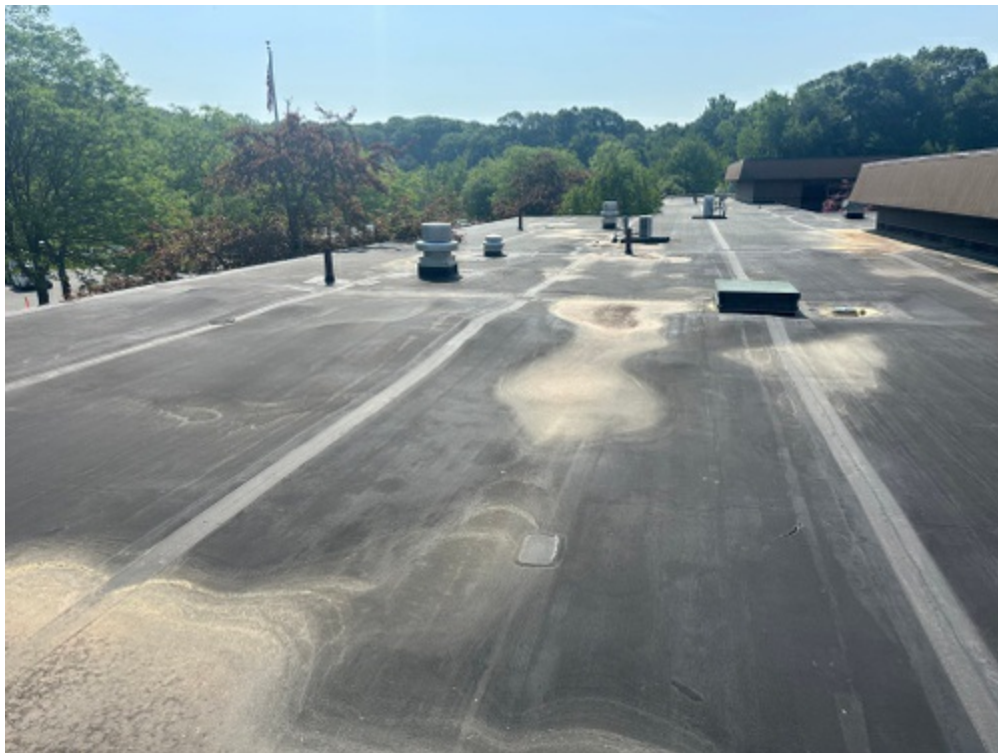
Photo 21

Failed insulation and
ponding.

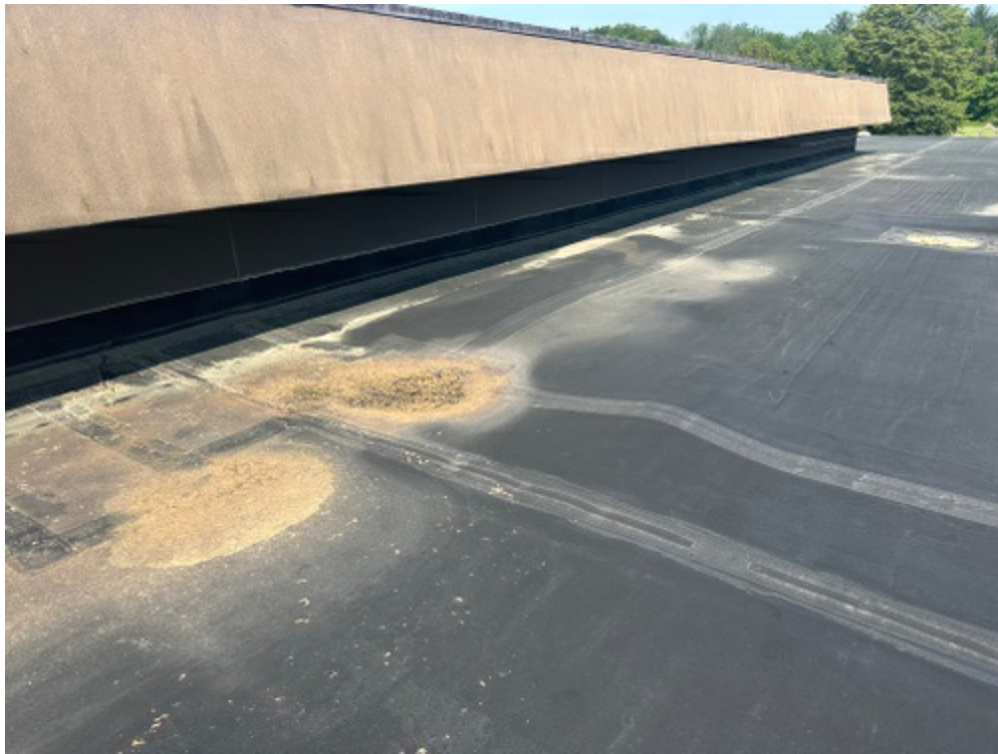
Photo 22

Failed insulation and
ponding.
