Project Title
**ROOF
ASSESSMENT
REPORT**
MARGARET A. NEARY
ELEMENTARY
SCHOOL
53 PARKVILLE RD,
SOUTHBOROUGH, MA, 01772

**DAMAGED ROOF
ASSEMBLY PLAN**

Submission
**ROOF INVESTIGATION
REPORT**

Date JANUARY 23, 2026

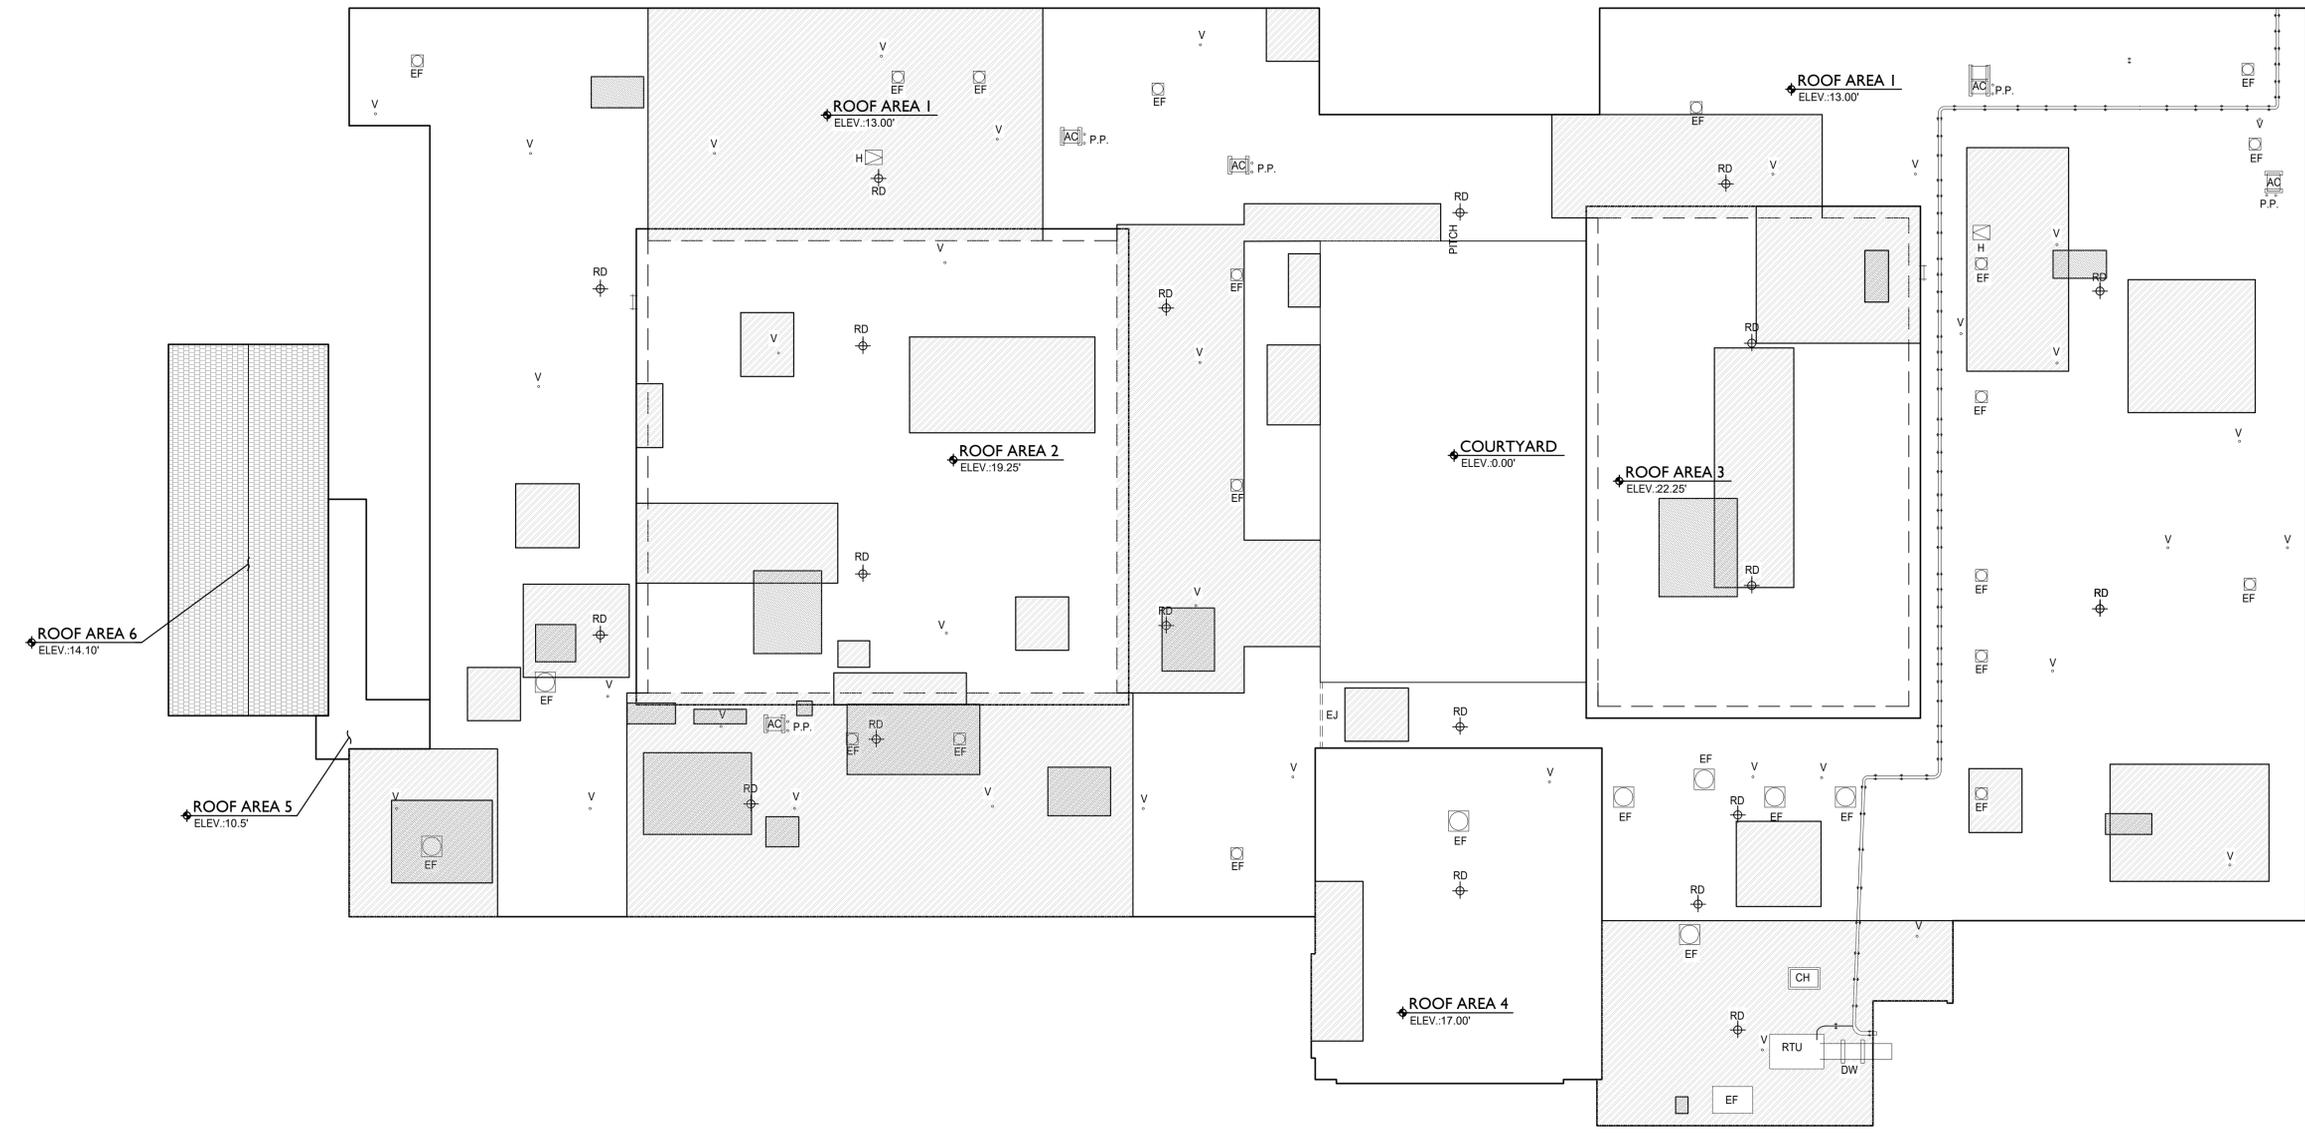
1 ROOF AREA PLAN
Scale: 1/16" = 1-0'

ROOF LABEL	SQUARE FEET	ROOF TYPE	SF OF ROOF DAMAGED/DISPLACED	% OF ROOF DAMAGED/DISPLACED	SF OF ROOF IR MOISTURE SIGNALS	% OF ROOF IR MOISTURE SIGNALS
ROOF AREA # 1	42,100	EPDM	18300	43.5 %	1475	3.5 %
ROOF AREA # 2	8300	EPDM	1600	19.2 %	200	2.5 %
ROOF AREA # 3	6060	EPDM	1470	24.5 %	315	5.2 %
ROOF AREA # 4	3400	EPDM	285	8.3 %	0	N/A
ROOF AREA # 5	475	EPDM	0	N/A	0	N/A
ROOF AREA # 6	4350	SHINGLES	0	N/A	0	N/A
AREA TOTAL	62,450
