PINE HILL AND PARMENTER ROADS

TRAFFIC & SAFETY CONCERNS

OCTOBER 15, 2019

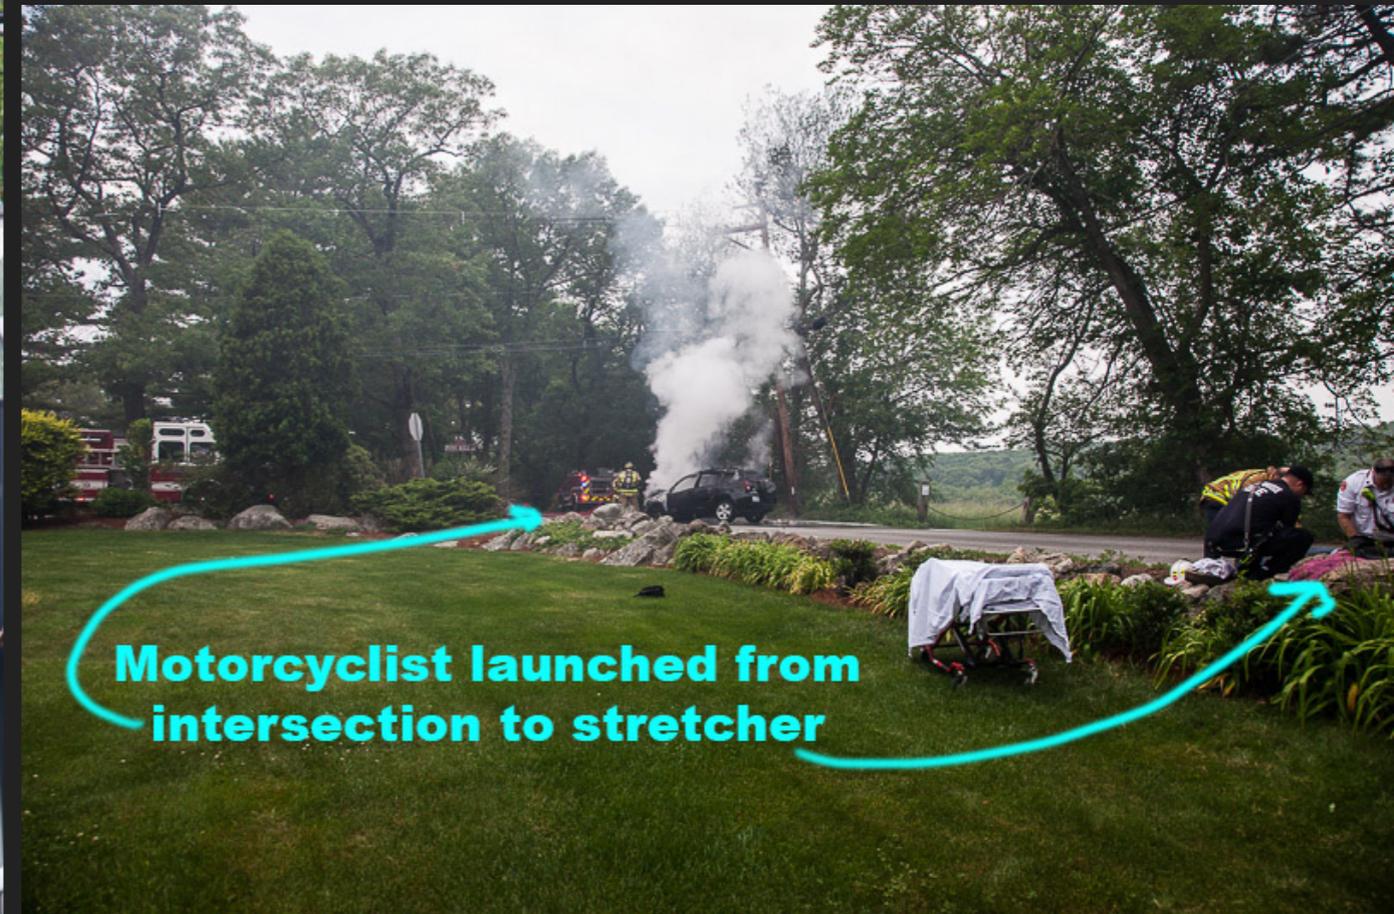
Motorcyclist launched from intersection to stretcher

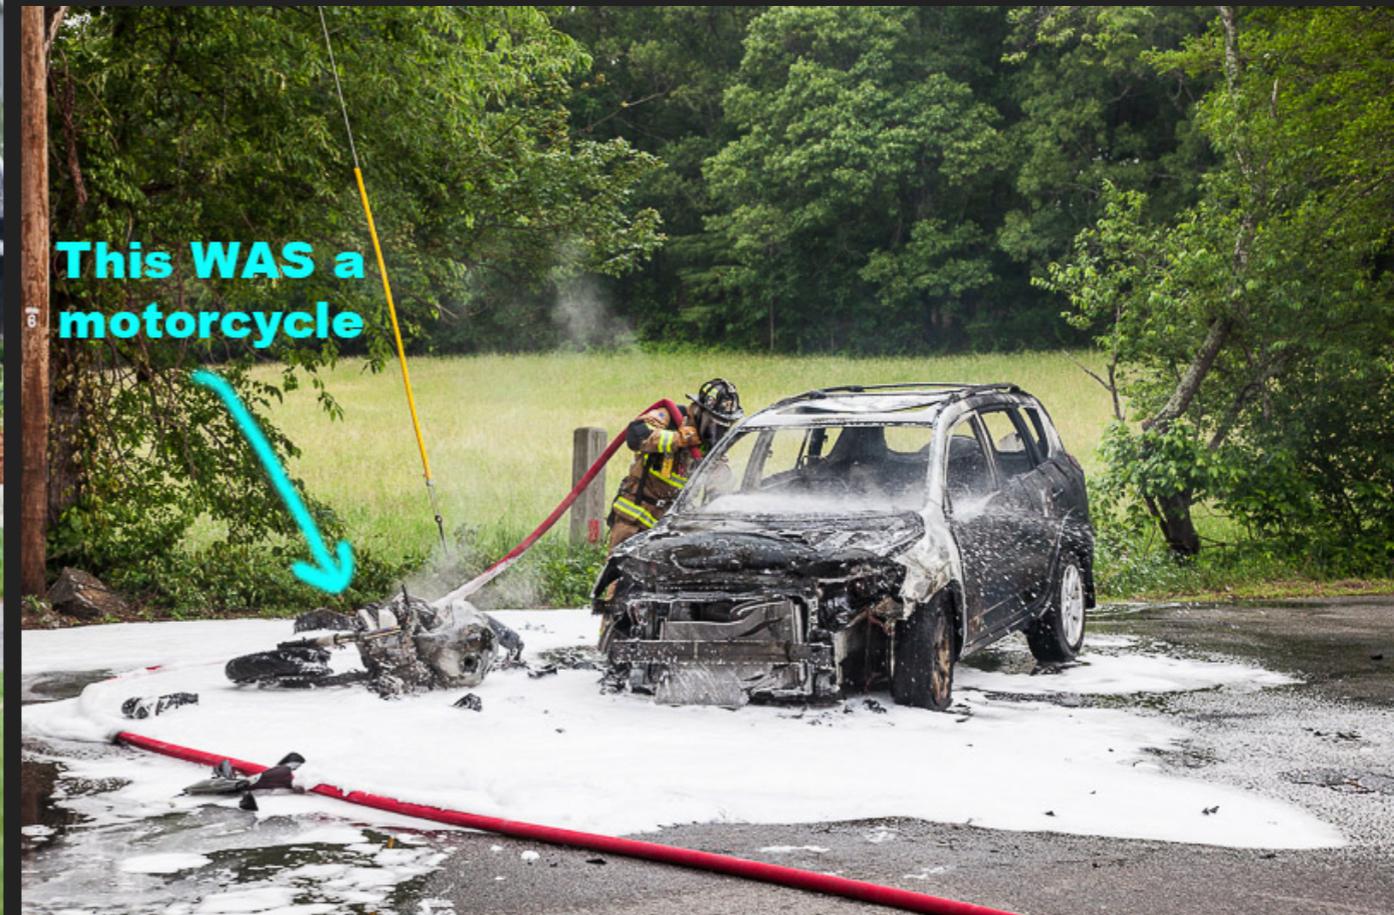
This WAS a motorcycle

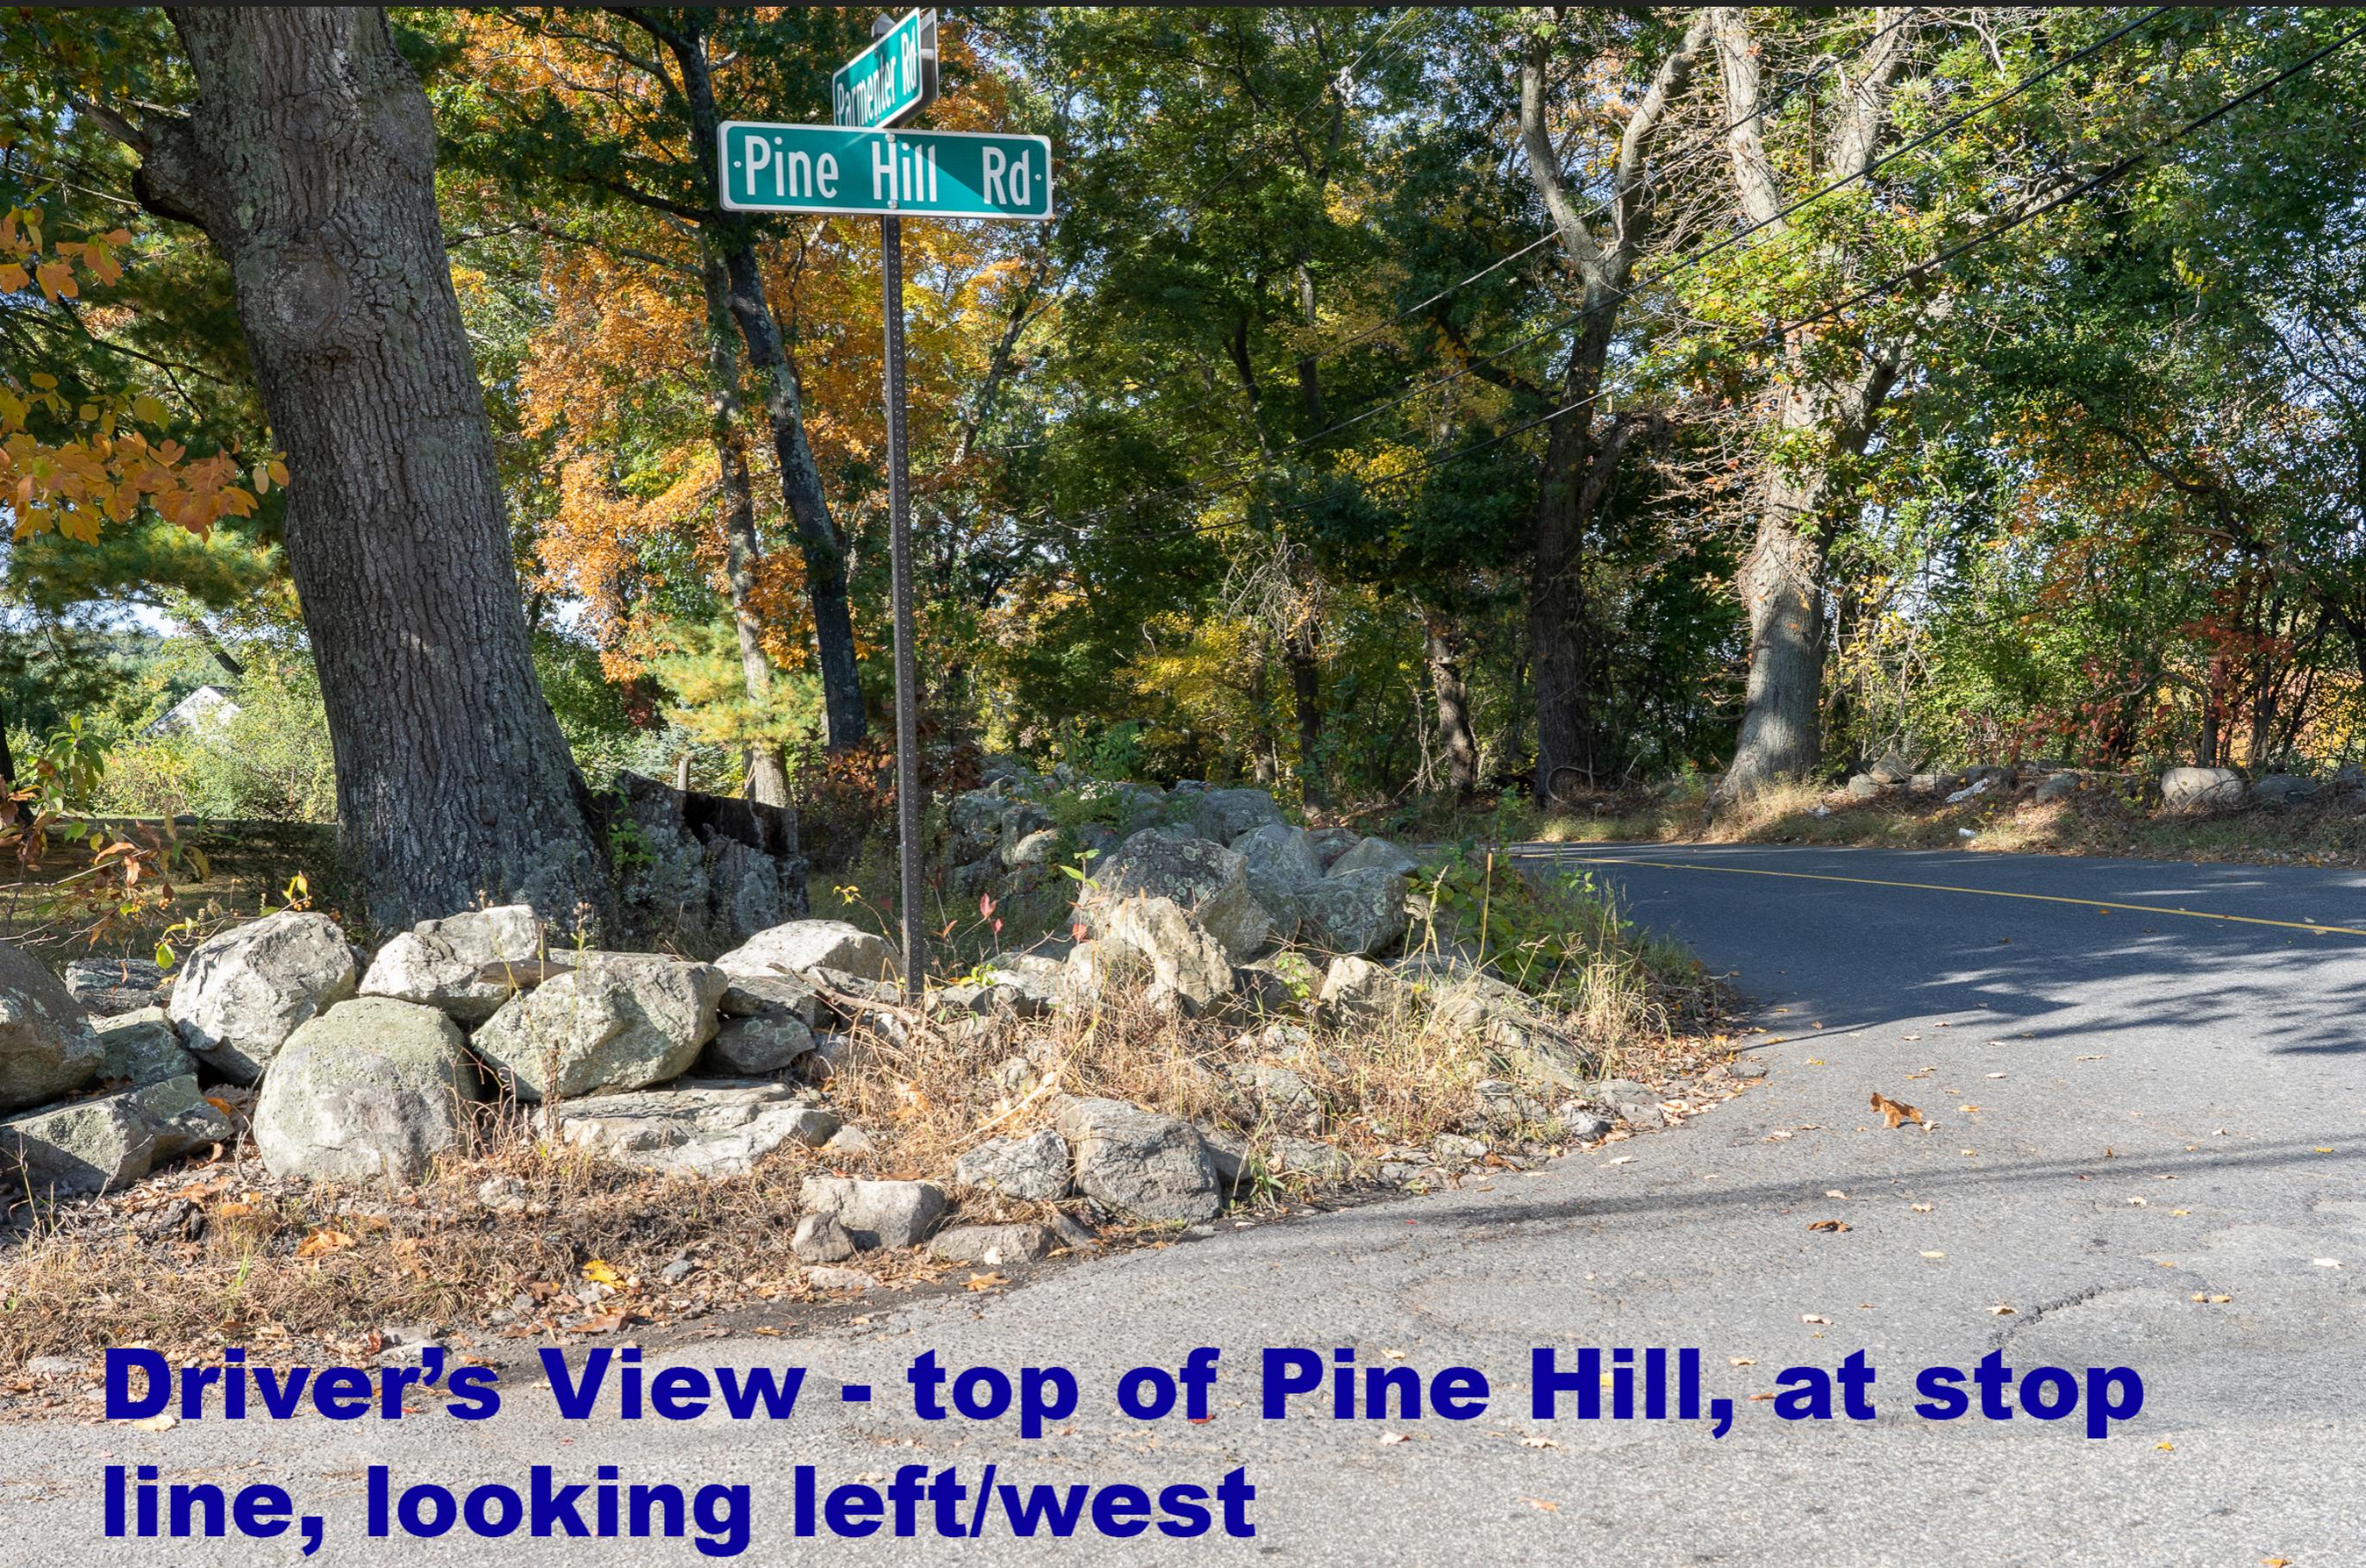
Taking a left turn from Pine Hill onto Parmenter Road is still treacherous. Drivers visibility is poor in both directions, given the topography/terrain and speed of traveling vehicles. The speed of vehicles on Parmenter is a serious problem.

Driver's View - top of Pine Hill, at stop line, looking left/west

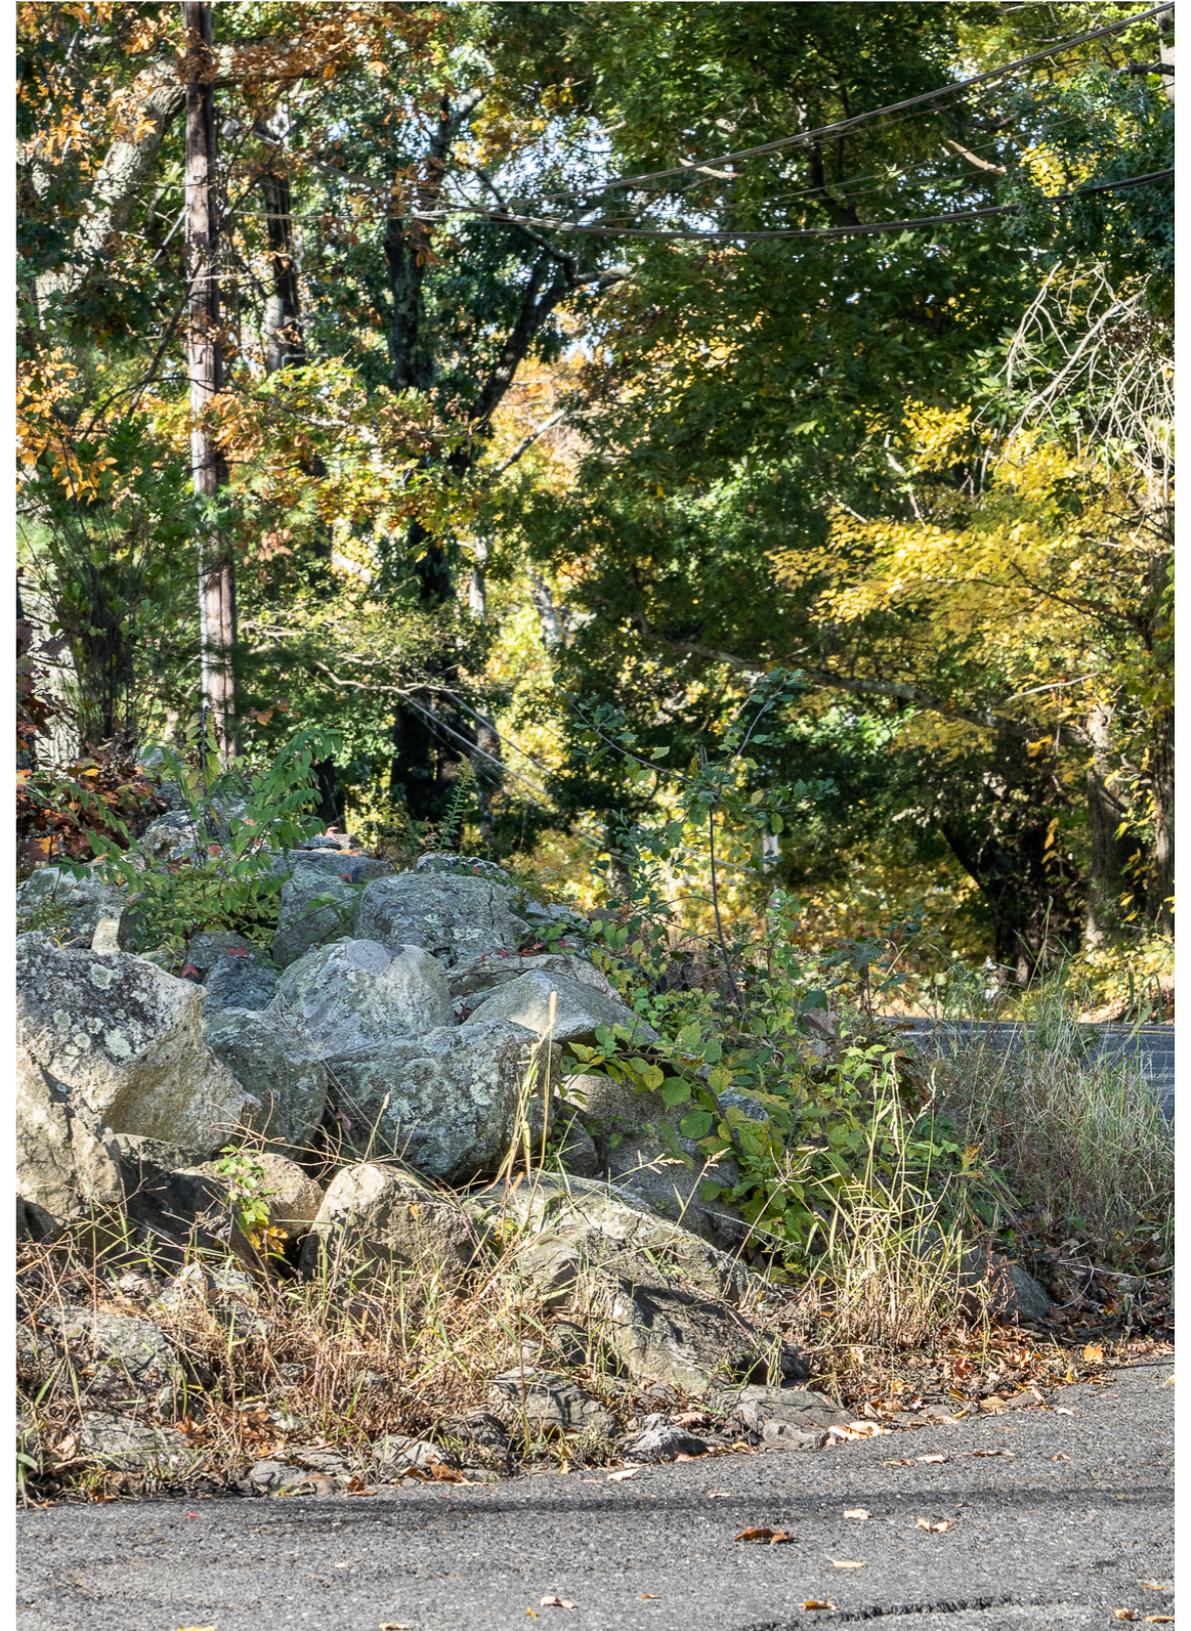
- ▶ In 2015, the engineering report stated that the following (optional) criteria are satisfied for an all-way stop warrant:
 - ▶ The need to control left turn conflicts (sight line is currently 50 feet looking west)

- ▶ Removal of vegetation at the corner to improve sight lines (photo at right taken 10/15/19)
- ▶ Installation of a Three-way Stop Sign at the intersection of Pine Hill/Parmenter Roads, and installation of associated warning signage.

- ▶ If a 3-way stop is truly something the town is unwilling to do, then installation of a speed table or other similar device that covers the entirety of the intersection at Pine Hill Road/Parmenter Road should be pursued. Or, other measures as recommended by the experts to increase safety at the intersection. More must be done.
- ▶ Installation of crosswalk for pedestrians to access Callahan State Park from Pine Hill Road
