**SPECIAL TOWN
MEETING TUESDAY,
OCTOBER 18th 7:00PM
TROTTER SCHOOL**

Main Street's Infrastructure Problems

They are real.

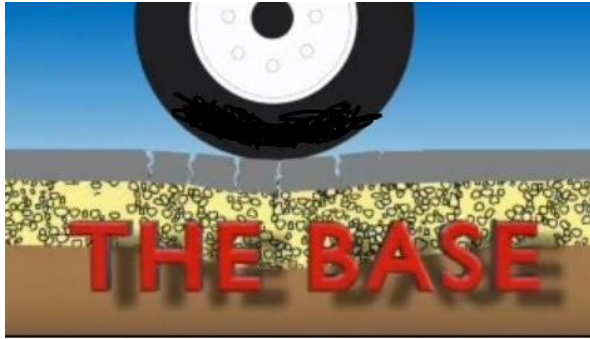
A poor base allows too much flex in the pavement, causing cracks.

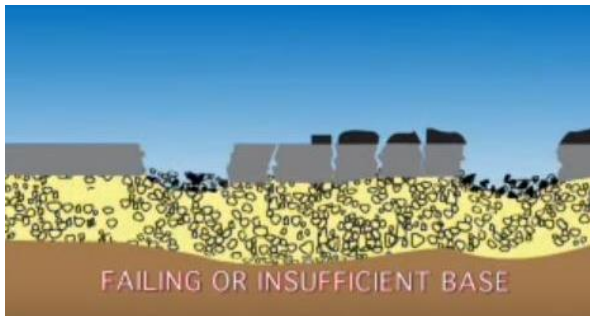
Cracks are filled to minimize water and ice damage and pot holes are filled, pavement is added.

The underlying problem has not been solved and the road surface will continue to deteriorate due to its poor foundation.

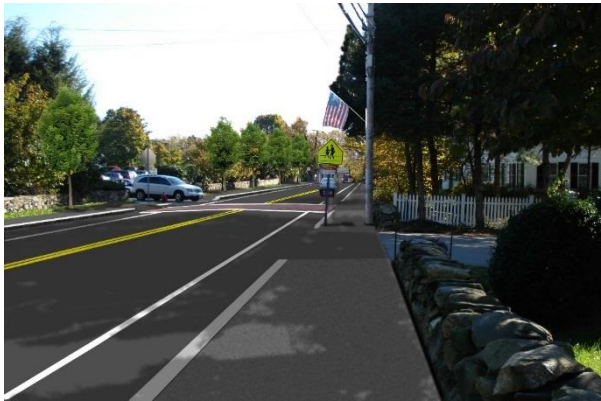
Paving Main Street without properly fixing the road's foundation would be fiscally irresponsible.

Paving over the existing base will not last. Under the current traffic load cracks will appear within a year, pot holes within 4 years.

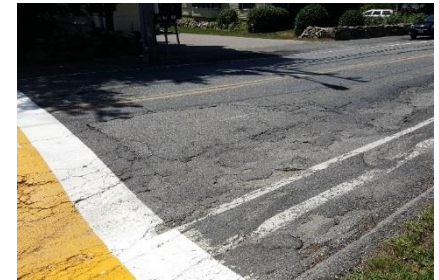
What are the pavement and infrastructure issues? Main Street is failing from underneath, it is not wearing from the top. The dirt under the road is not able to support the traffic on Main Street. Putting new pavement over a poor sub-base is fiscally irresponsible. You wouldn't build a house on beach sand with no foundation. So why would you re-pave a road with a poor foundation?
southboroughtown.com/mainstreet

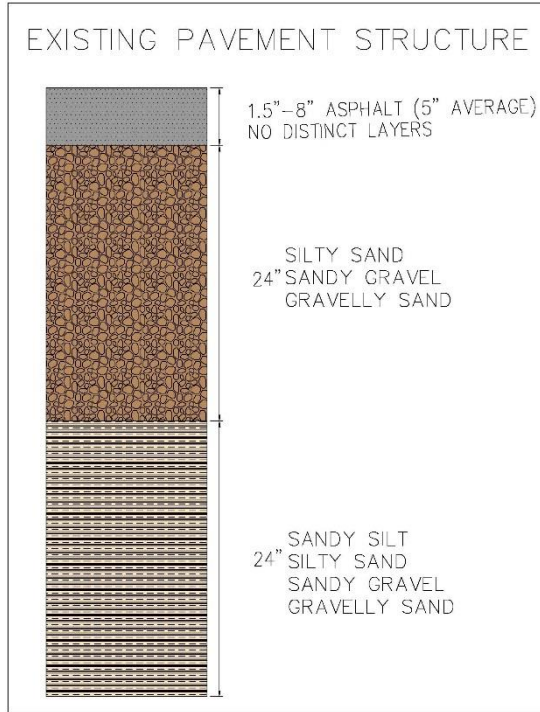
Main Street's Current Base

The above pavement structure represents the current road structure of Main Street based on test pits done along the project. Sand is the most prominent element in the road base. Sand rolls, as you know from walking on a beach, and allows the pavement to flex. There is up to 8" of asphalt in some areas along Main Street, but even those areas are failing.
